City of Muscatine

IN-DEPTH ITEM – CITY COUNCIL

East Hill Multi-Use Facility Direction for Design Consultant

In August 2020, Legat Architects was awarded the contract for a Fire Station Facility Assessment Conceptual Plan. This work included an existing condition assessment of the site and all buildings, cost benefit analysis to construct new or renovate to create a fire station, and a conceptual building design for a new stand-alone fire station or renovation of the existing building into a fire station.

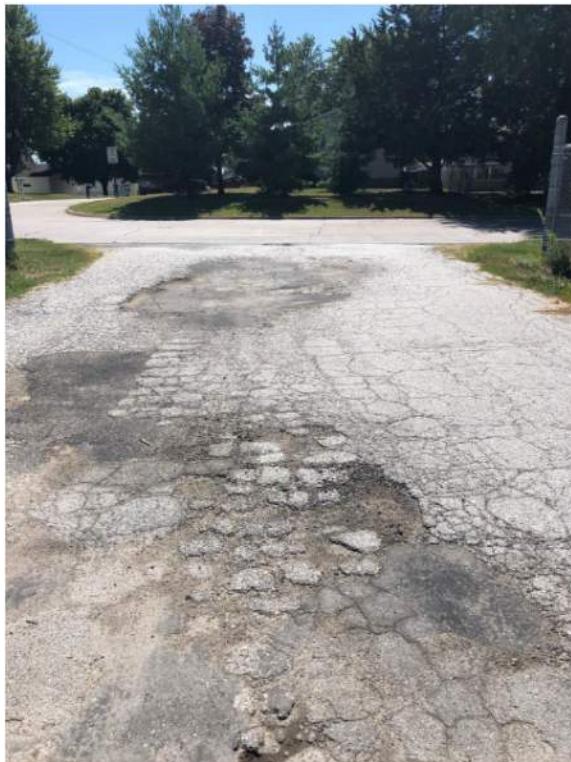
Picture 1: Asphalt pavement at existing entrance. Looking south.

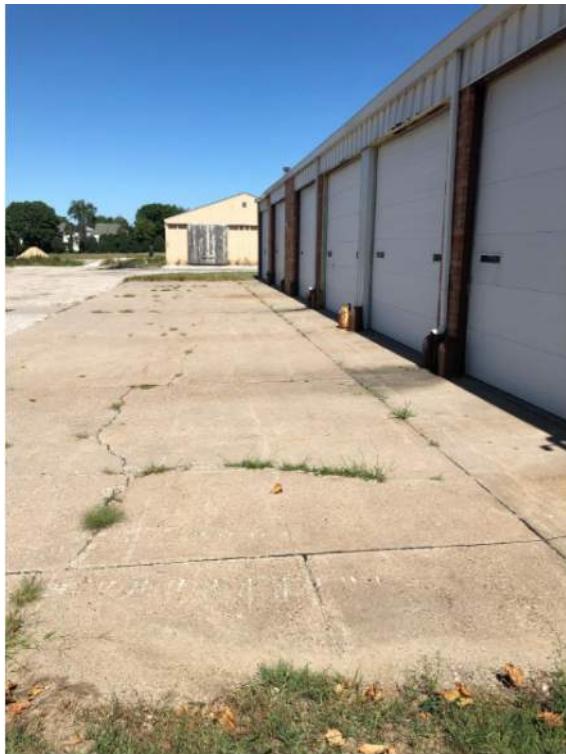
Picture 5: Cracked concrete west of main building. Looking north.

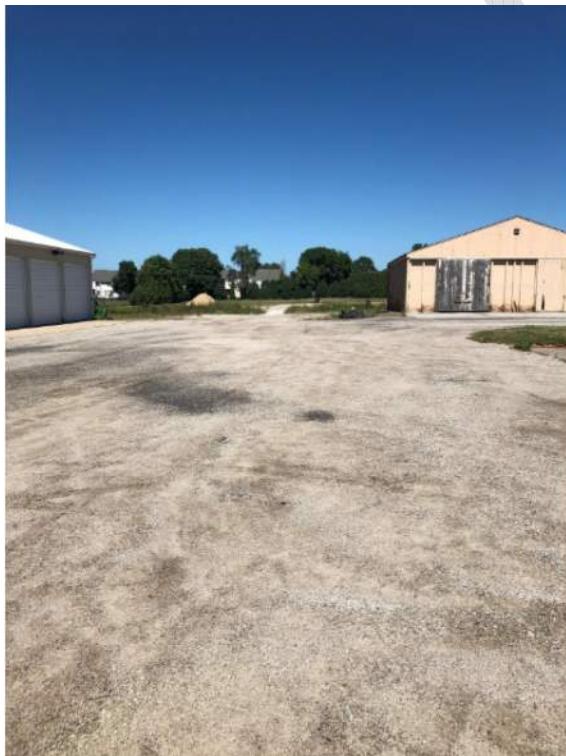
Picture 6: Rock surfacing west of main building. Looking north.

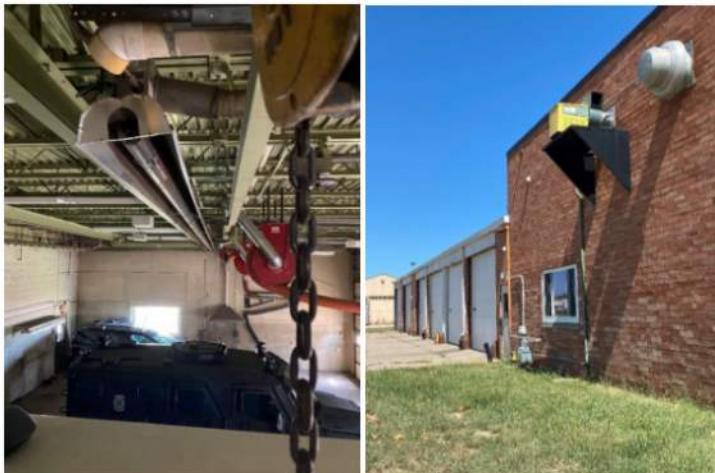
- The secured garage with 3 bay doors currently has vehicle exhaust reels and is heated via infrared gas fired units at the ceiling level. The garage has exhaust fans serving the vehicle exhaust as well as the garage in general, and there is a hood within the space that is exhausted outside. The vehicle exhaust reels appear to be in good working order. The infrared heaters need some repair at exhaust and intake connections at minimal. The current state of the units are nearing life expectancy looking at burner tail pipes and reflective fins. Recommendation would be to replace infrared heaters in this garage bay.

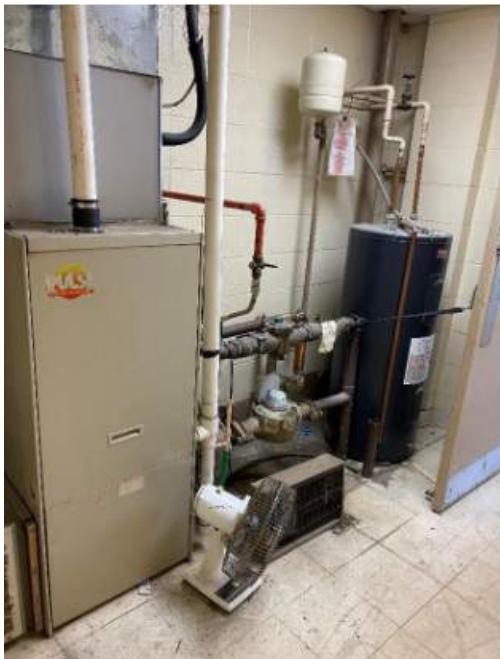
- Incoming water service is intact and it's galvanized steel. It's per code with backflow and blow down. No changes seen to be made.

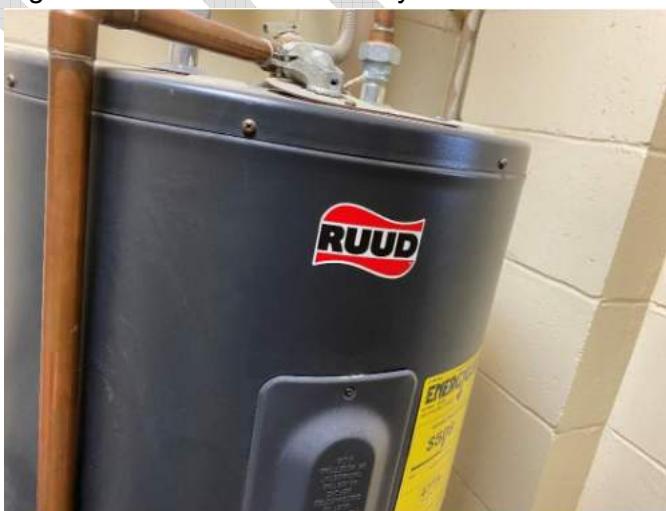
- Existing water heater was manufactured in 2012. It has roughly 5 years left on it's life expectancy. It's an electric water heater with an upper and lower element. With gas piping so close to the unit, I'm surprised that a gas fired unit wasn't installed. When the department chooses to replace the water heater, I'd recommend looking to replacing with a gas fire heater for lower utility costs.

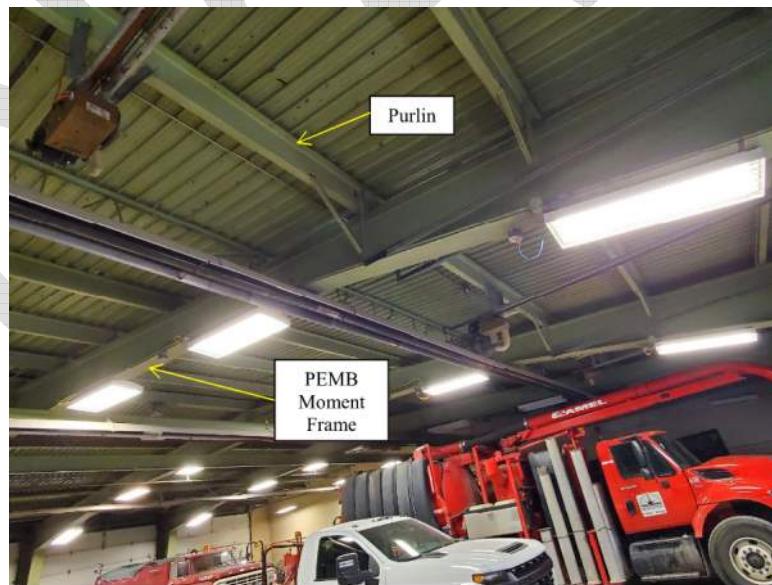
Figure 8. PEMB Roof Framing

The building is in very good condition, and no obvious structural deficiencies were noted. However, in changing the building usage from a Department of Transportation garage facility to a fire station, the risk category for structural design loading increases from a Risk Category II to a Risk Category IV building. This acts to increase the structural loading requirements for the structure, either through additional assumed loading or through additional detailing requirements.

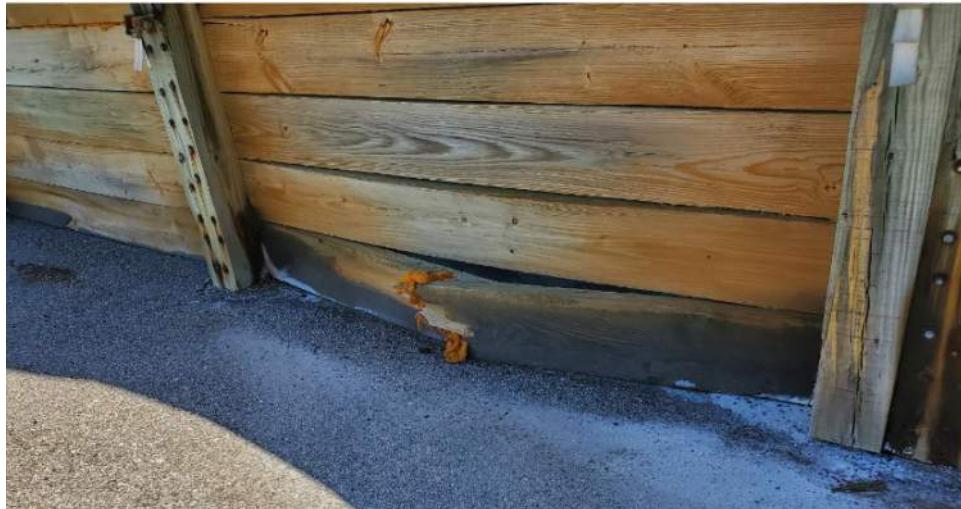
Cracked wall planks were noted all-around the structure (see Figure 10 and Figure 11). This is most likely due to a combination of the lateral pressure exerted on the planks from the granular material stored inside the building and the additional lateral loading generated by loading equipment (skid loader or front end loader) pushing on the walls when filling their buckets.

Figure 10. Out-Building 1 Broken Wall Plank

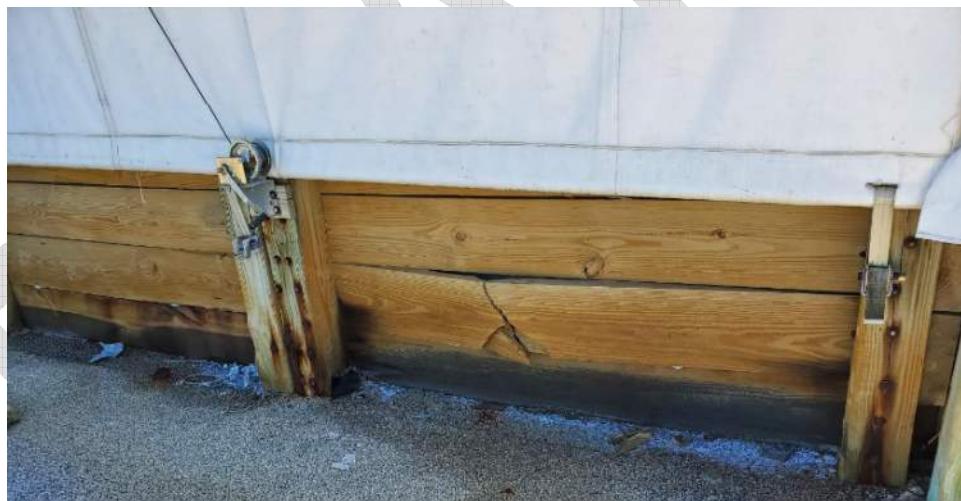
Figure 11. Out-Building 1 Broken Wall Plank

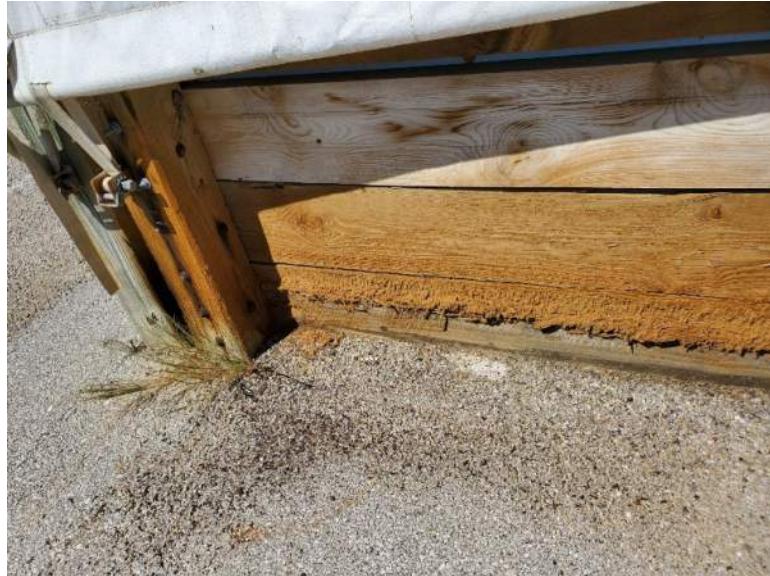
Deterioration was also noted in the wall planks themselves. The planks have rotted on the exterior face, leaving a “hairy” or “furry” texture (see Figure 12). This is often explained by a heavy exposure to salts, and it is likely that this building could have been used for road de-icing salts at one time or another. However, it does not appear that the planks have rotted to worrying degree at this point in time.

Figure 12. Out-Building 1 Plank Deterioration

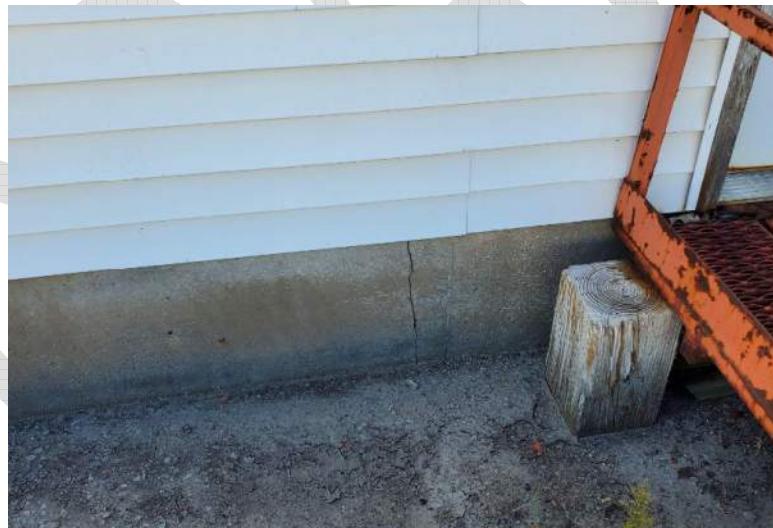
The building is surrounded by a concrete containment wall, encompassing the building and the small tank farm to the north of the building. Cracking was noted at several locations along the foundation/containment wall (see Figure 14 and Figure 15).

Figure 14. Out-Building 2 Foundation Cracking

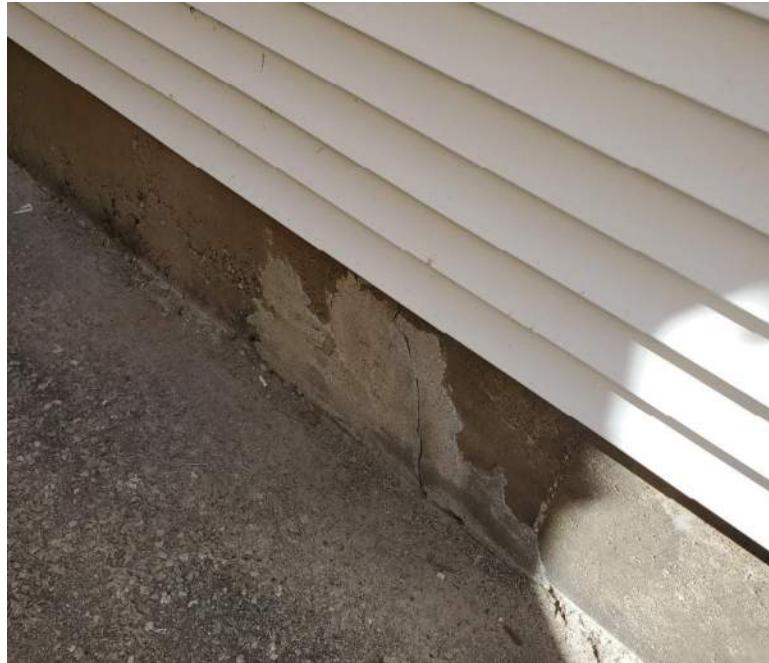
Figure 15. Out-Building 2 Foundation Cracking

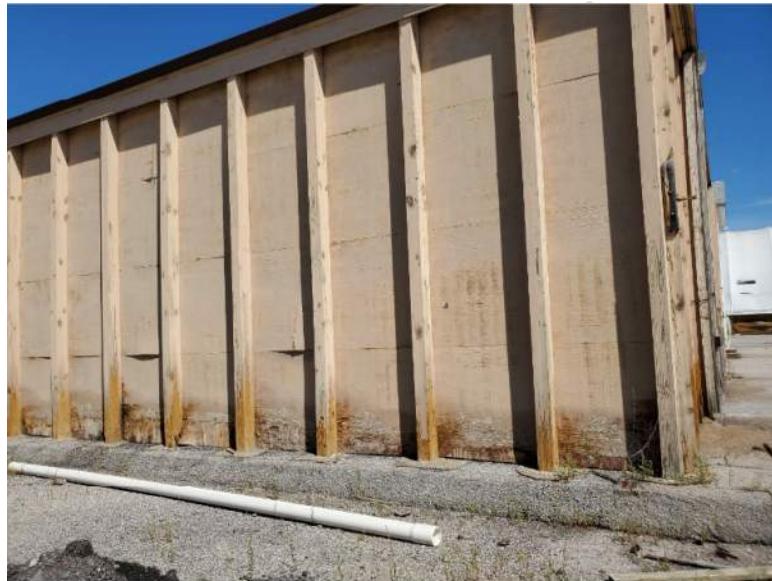
The plywood sheathing/siding has split, cracked, and rotted in many locations around the structure (see Figure 16 and Figure 17).

Figure 16. Cracking/Bowing Siding

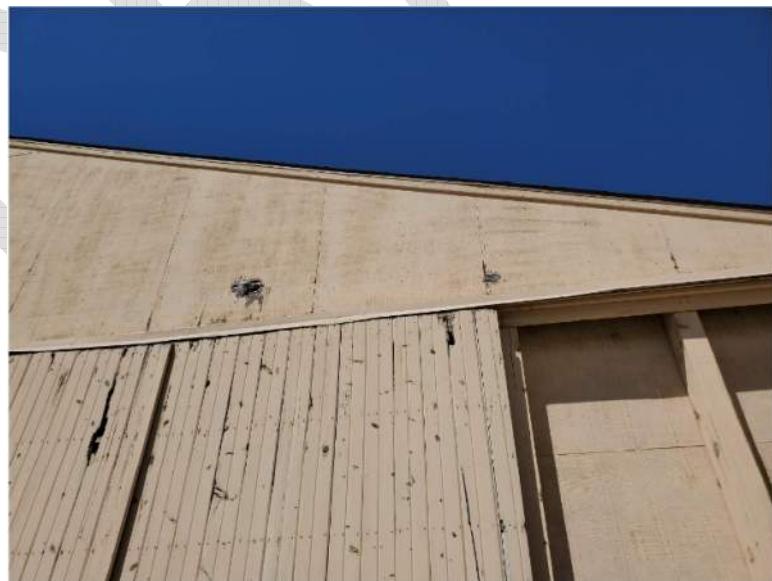
Figure 17. Cracked/Damaged Siding and Door

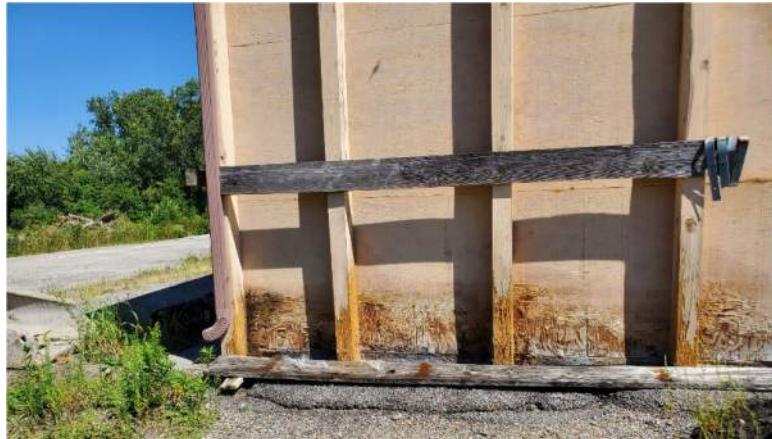
Further, the same “furry” or “hairy” rotting of out-building 1’s wall planks is noted on the lower portion of the sheathing and the main building poles (see Figure 18).

Figure 18. Salt Deterioration on Siding and Poles

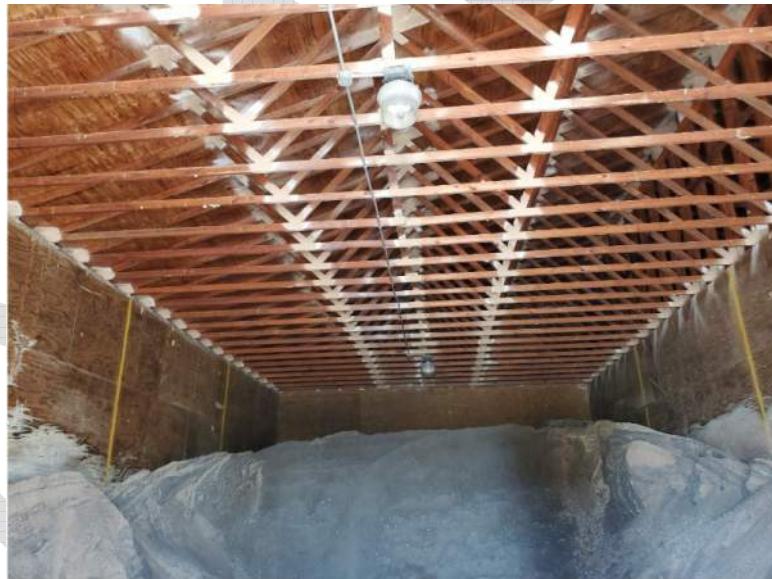
However the roof framing is fully exposed and appears to be in very good shape (see Figure 19).

Figure 19. Out-Building 3 Interior Framing

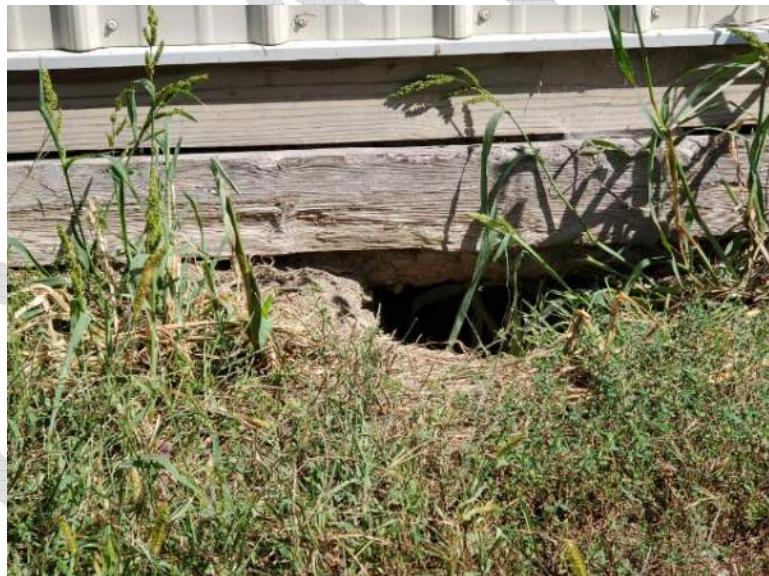
The building is relatively new and, as such, is in very good condition. However, during inspection, an animal burrow was discovered beneath the building slab on the building's west side (see Figure 21). This cavity in the soil beneath the slab can undermine the floor slab, reducing its strength resulting in undesirable cracking and settlement.

Figure 21. Out-Building 4 Animal Burrow

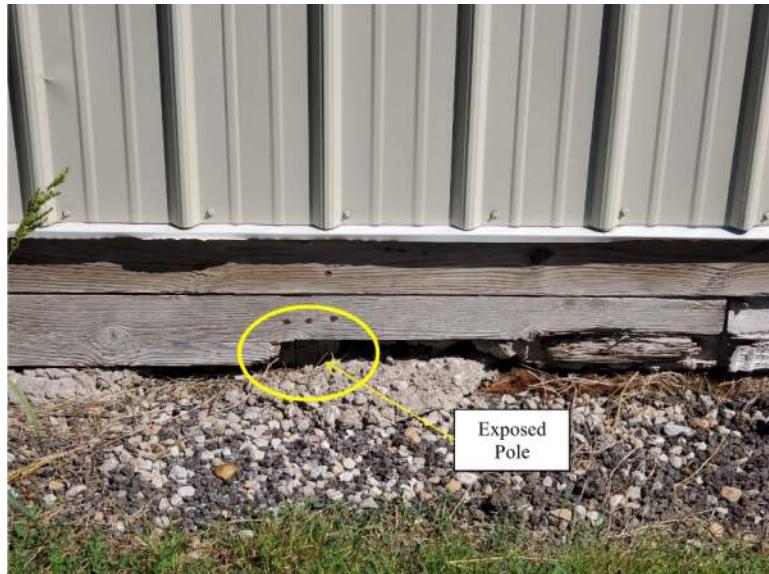
The condition of the base board running around the exterior of the building has begun to deteriorate, exposing the load-bearing poles to the elements (Figure 22 and Figure 23).

Figure 22. Out-Building 4 Rotting Base Board with Exposed Pole

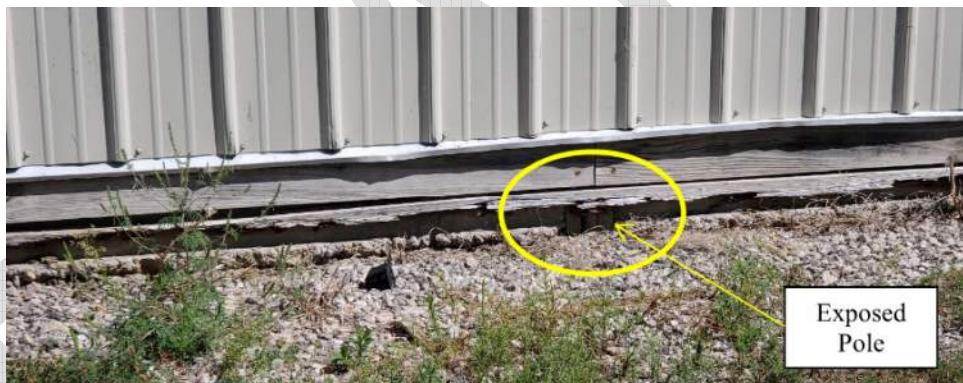
Figure 23. Out-Building 4 Rotting Base Board with Exposed Pole
