# City of Muscatine Art Center & Museum

## Energy Conservation Study

A&J #201310.00

**Energy Conservation Study  
Muscatine Art Center Museum Building  
Muscatine, Iowa**

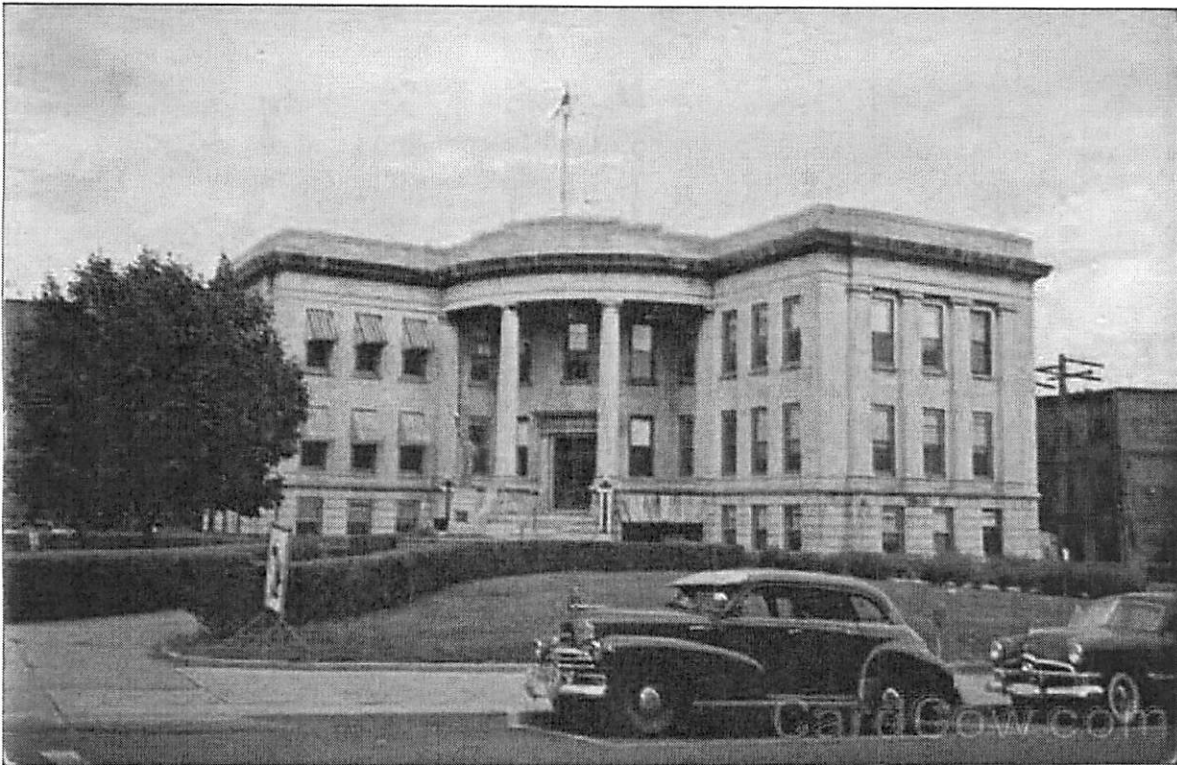
*Postcard showing awnings on one wing of the building ca 1950. This documentation could be used to support installation of awnings on the same windows or an alternate proposal to include additional openings as shown below.*
