Staff seeks City Council authorization to apply for an Iowa's Rural Heritage Revitalization Grant for implementation of the Historic Landscape Preservation Plan for the Japanese Garden.

Historic Landscape Preservation Plan for the Japanese Garden Laura Musser McColm Atkins House

**Muscatine Art Center
Muscatine, Iowa**

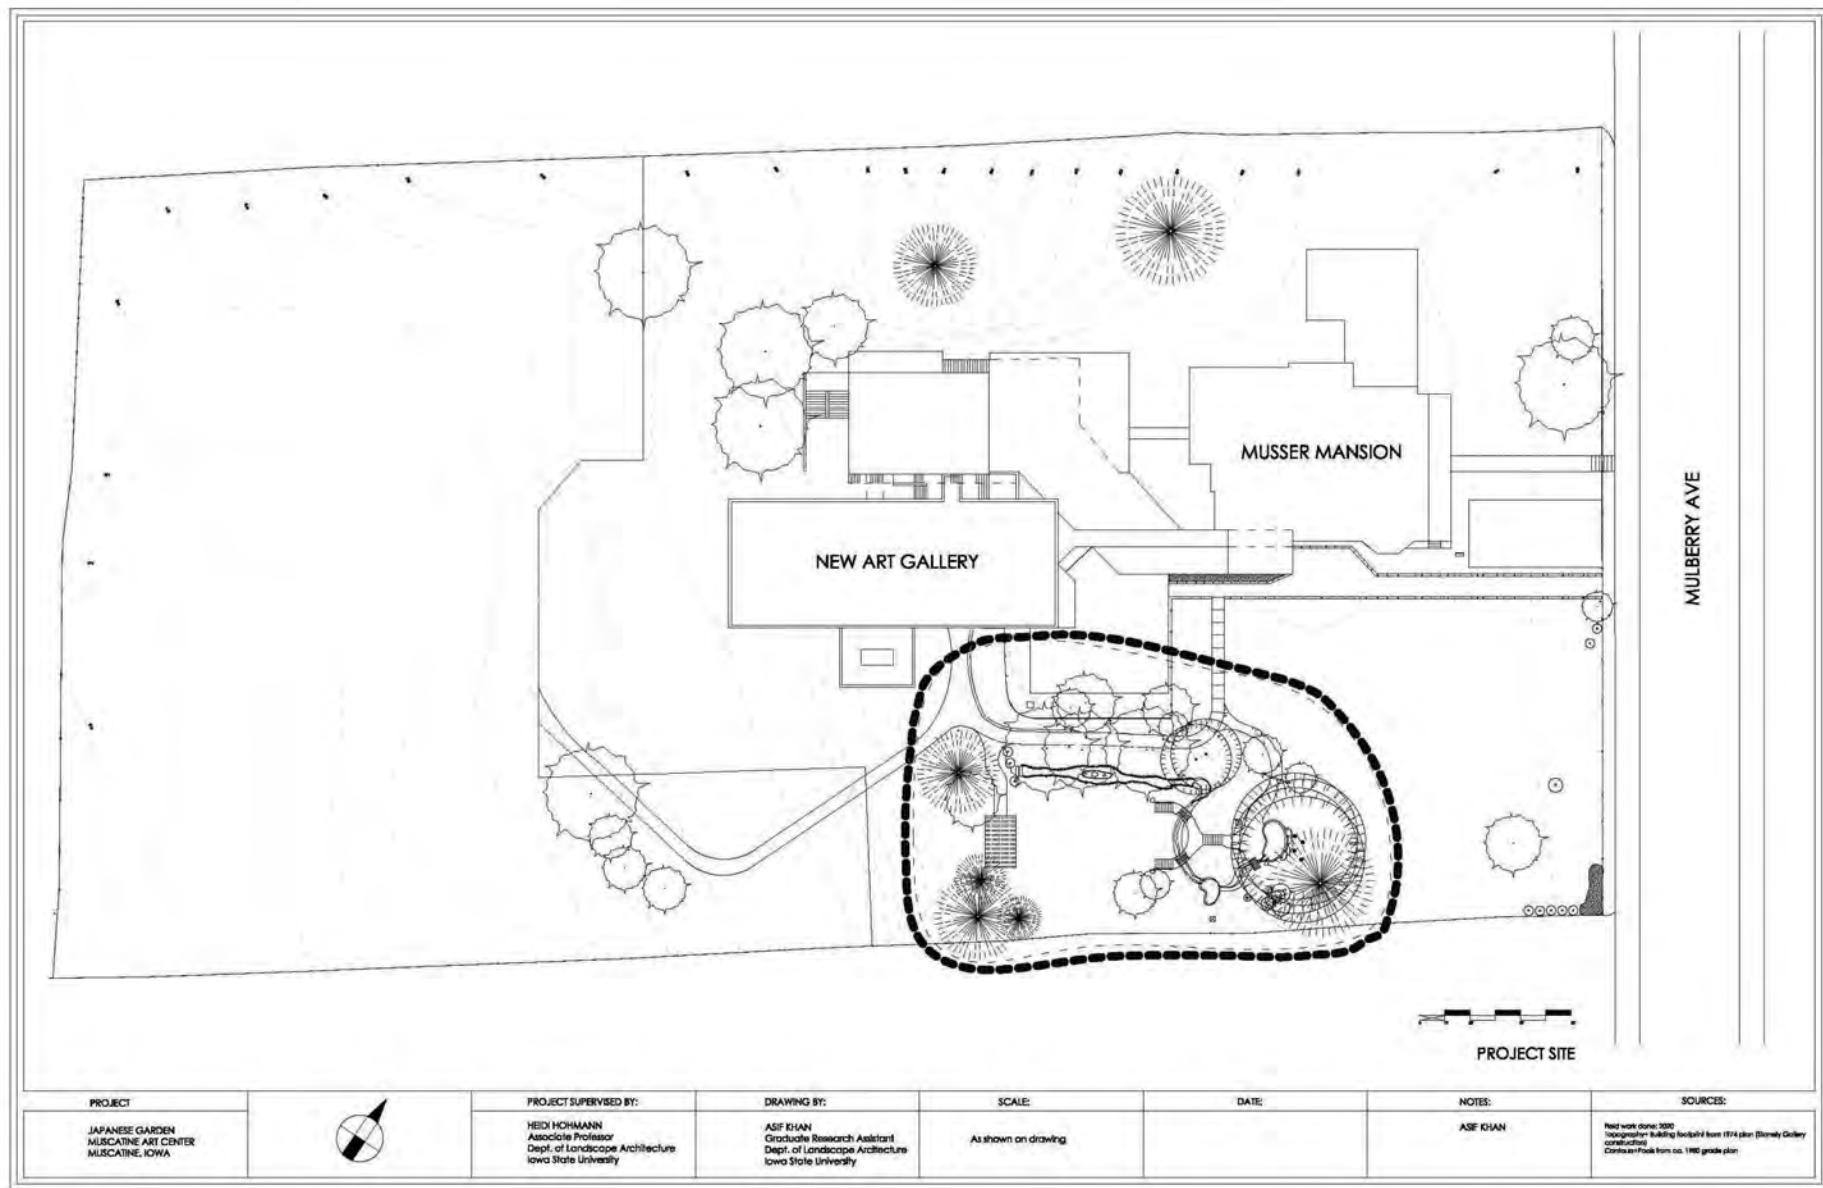
Figure 1: Overall Site Plan

In June 2020 we returned to the site for a day of field work, field checking the site plans from the 1970s and 1980s. Only the Japanese Garden was surveyed to locate new and eliminate missing features from the existing plans, using tapes and a rolling ruler to measure dimensions. Existing plants in the gardens were also identified and located. Two drawings of the site's existing conditions was created using AutoCAD, one of the Japanese Garden and one locating the garden within the overall site. These two drawings are presented here as Figures 1 and 2.

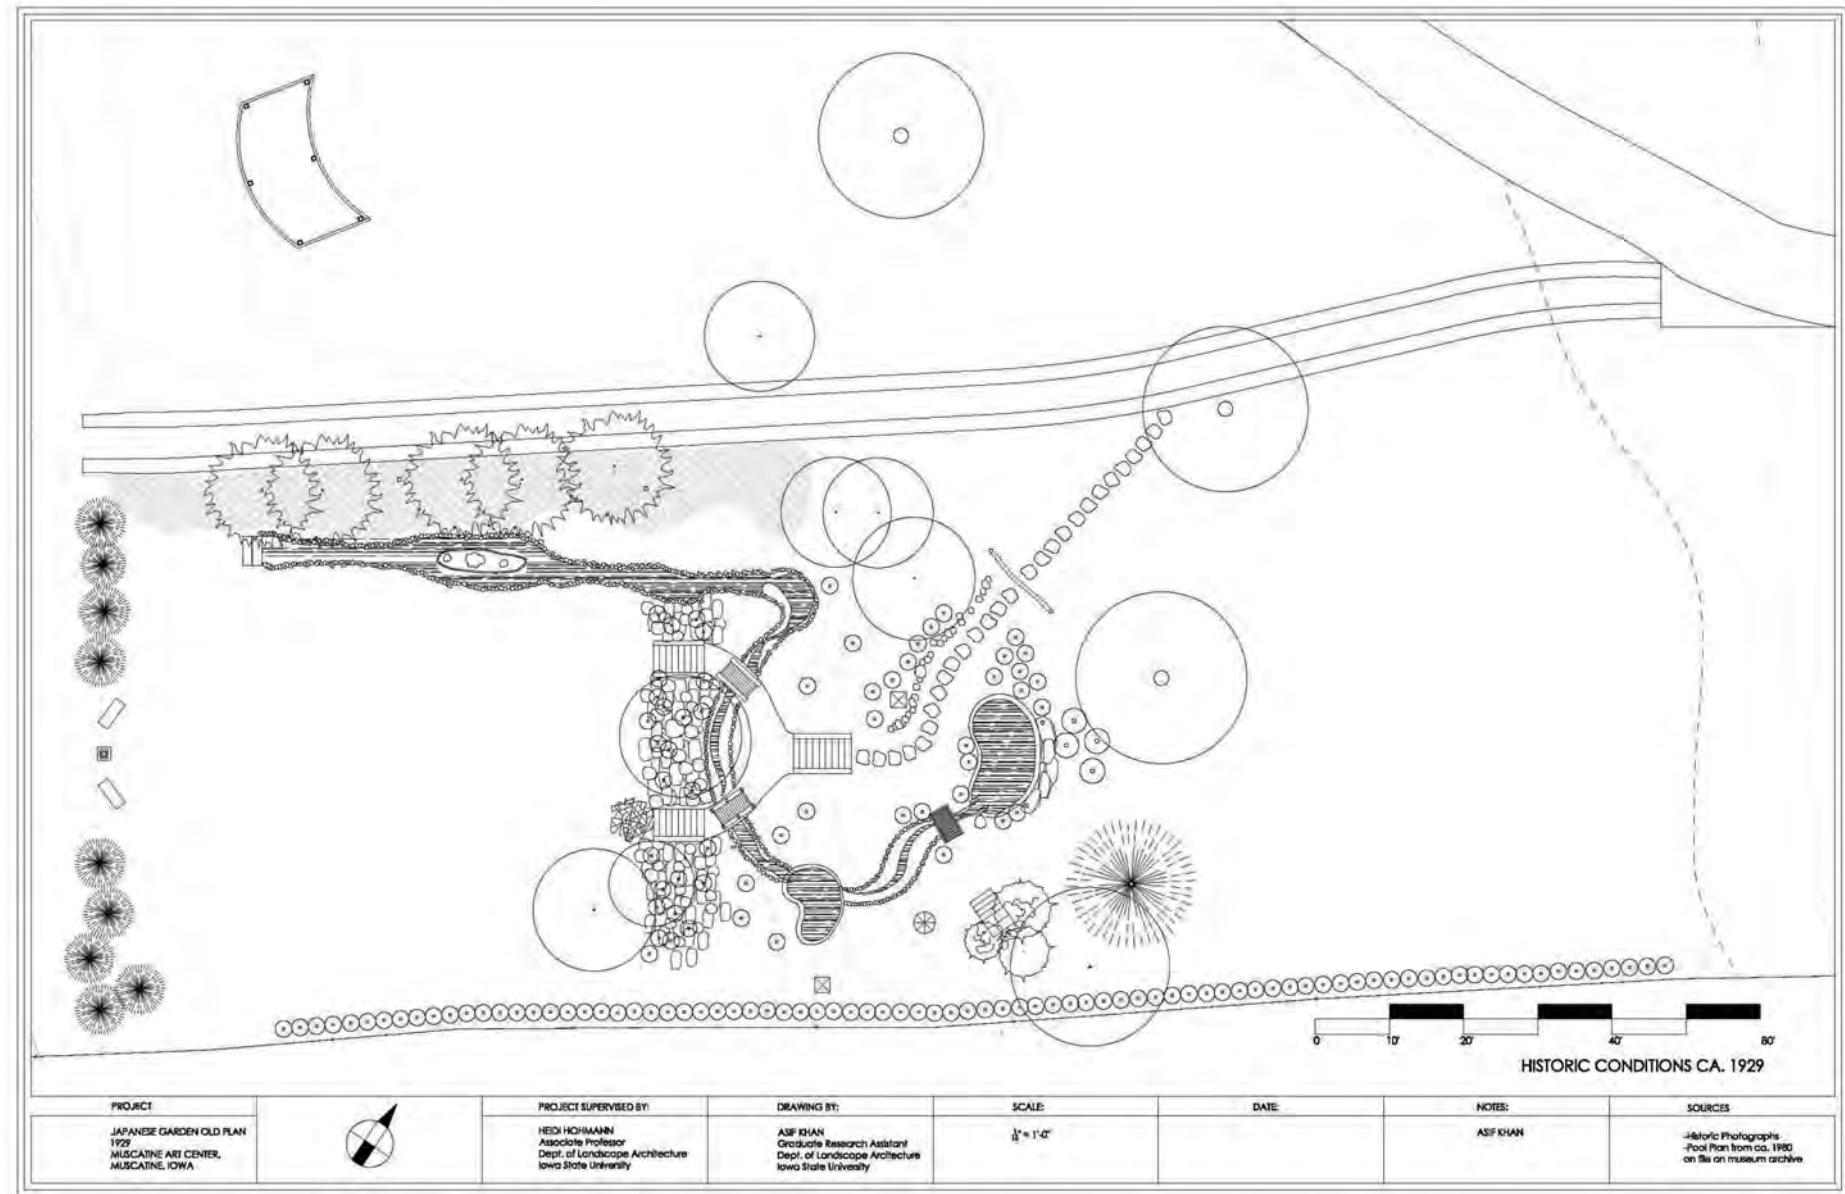
Figure 3: Historic Conditions Plan, ca. 1930s

A historic garden plan (Figure 3) was created to depict this time period. The drawing was constructed by using the existing conditions plan as a base plan. Historic photographs then were carefully examined and features from the photos and time period were located on this plan. Locations of features are thus approximate, though were of course carefully considered based on locations of features that are still extant.

However, historic photographs do reveal much about the garden's character during McColm-Atkins' tenure. These photographs have been used to create a plan depicting the garden's historic condition sometime around the mid 1930s (Figure 3). The plan was constructed using existing drawings and surveys from the museum's archives as baseline dimensional data, combined with dimensions

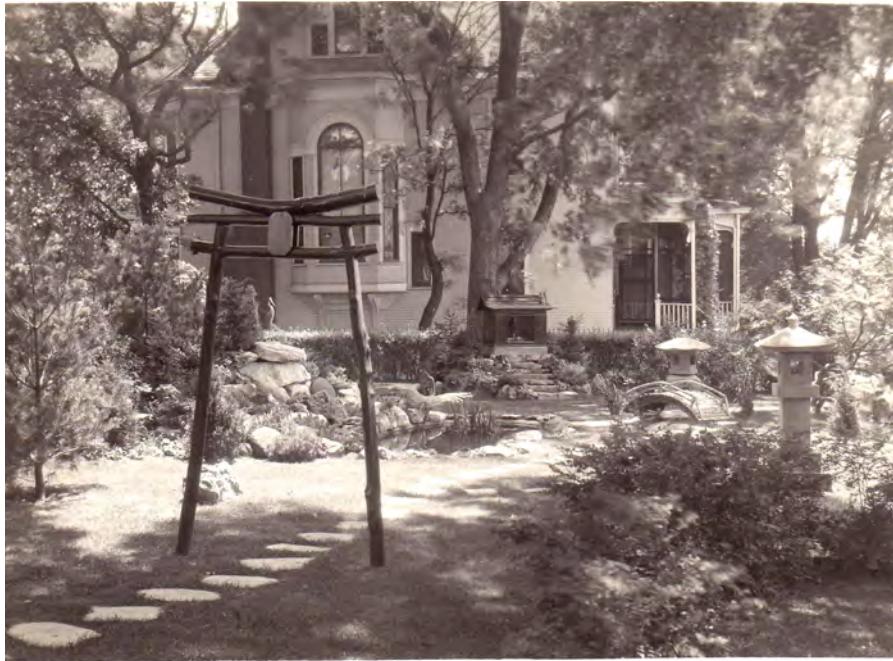
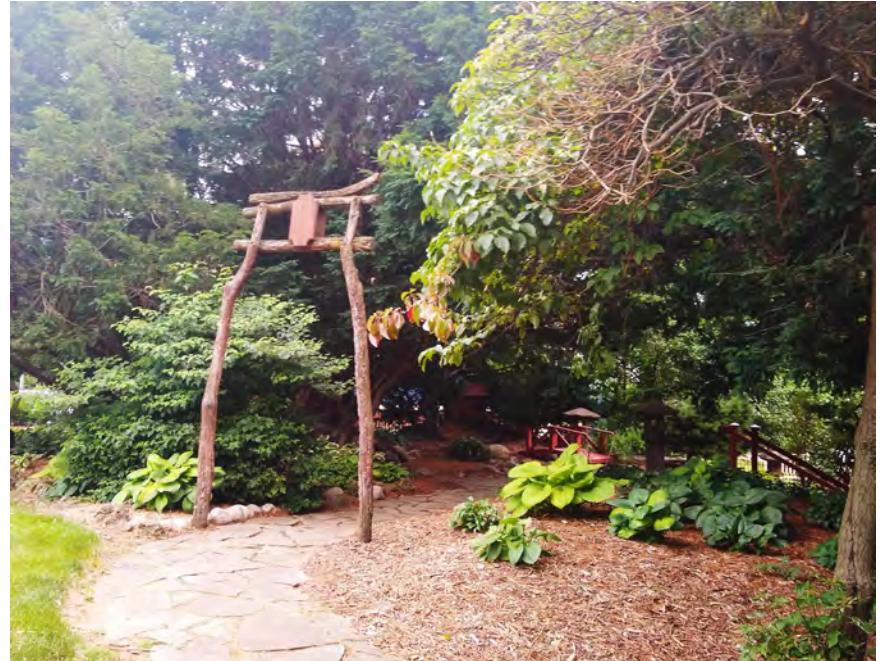
1965.292/M-862

- Historic garden is visually open and sunny, with layered plantings (canopy, understory, ground plane).
- Current garden's middle-story dominates; lacks ground cover and perception of high tree canopy.
- Pathway is now wide, not stepping stones; is curved to museum entrance today. Historically was oriented to front door. Torii is shifted.
- Loss of sun and increased shade has changed plantings and upper garden's sense of enclosure.

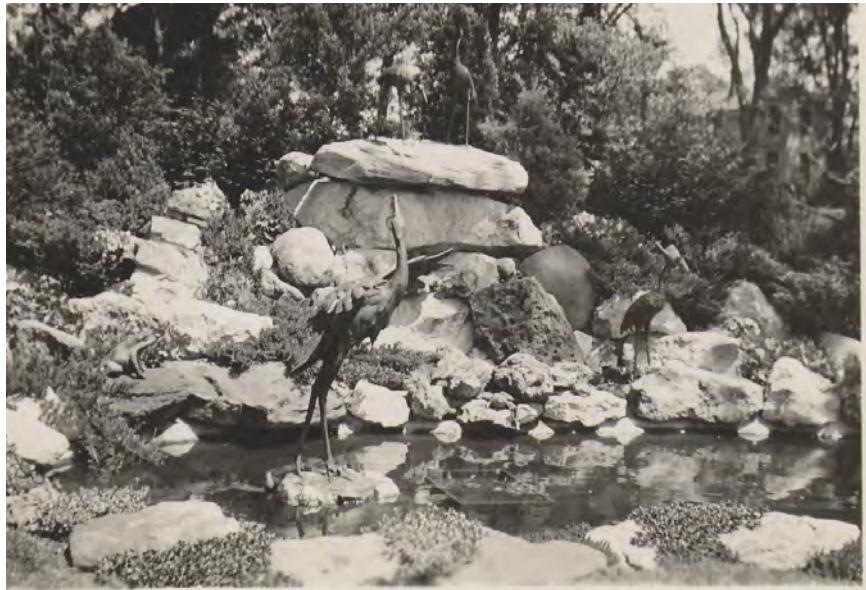
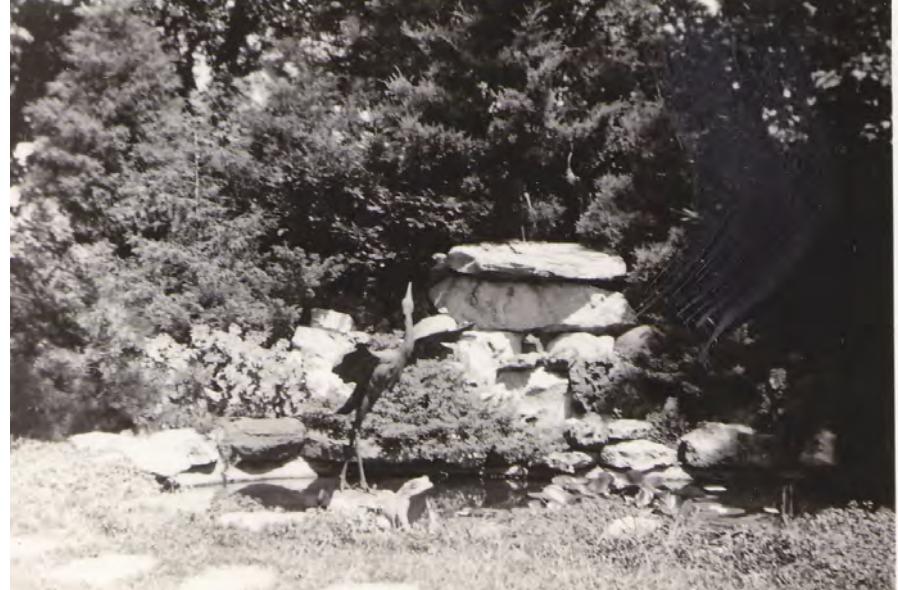
1965.281.1/1965.281.2

- Earlier photo on the left.
- Note the mixed evergreen composition behind stones and open sky in background in earlier photograph.

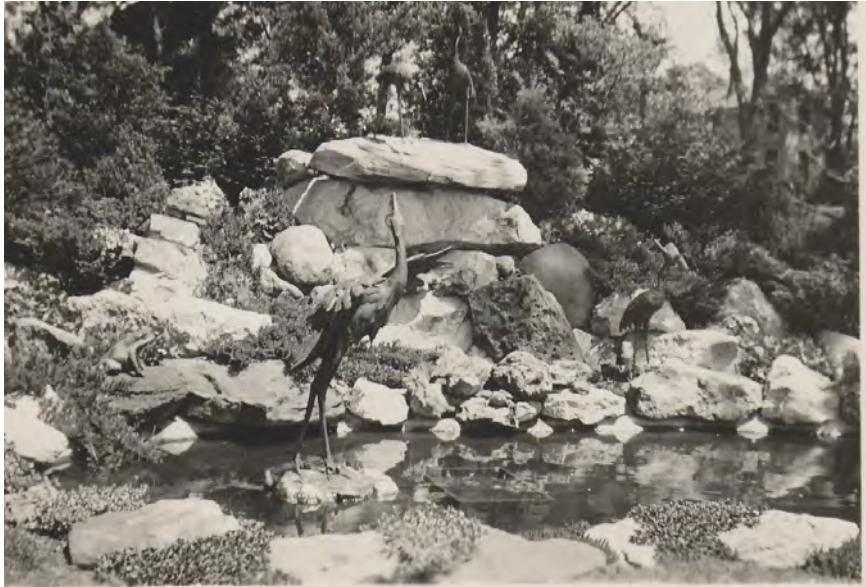
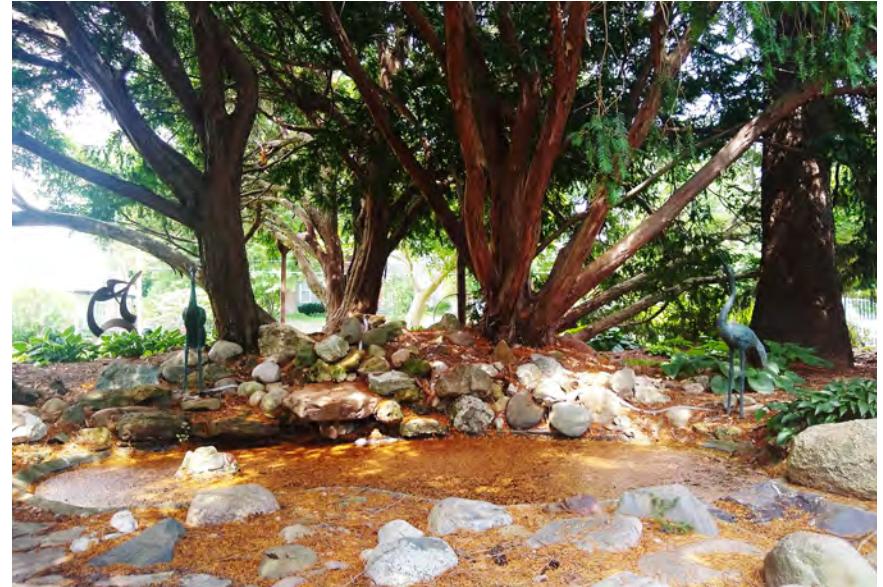
1965.281.1/M-394

- Note changes in size of stones, height of mound, arrangement of cranes, and the more varied composition of evergreens historically.
- Note reversed scale of rocks to vegetation; today, vegetation dominates.
- Today, sunlight openings appear in middle of photo, not top of photo as historically, showing change in enclosure.
- Note needles in pond today, changing reflective quality of water.
- Note loss of variety in plantings amid the rocks.

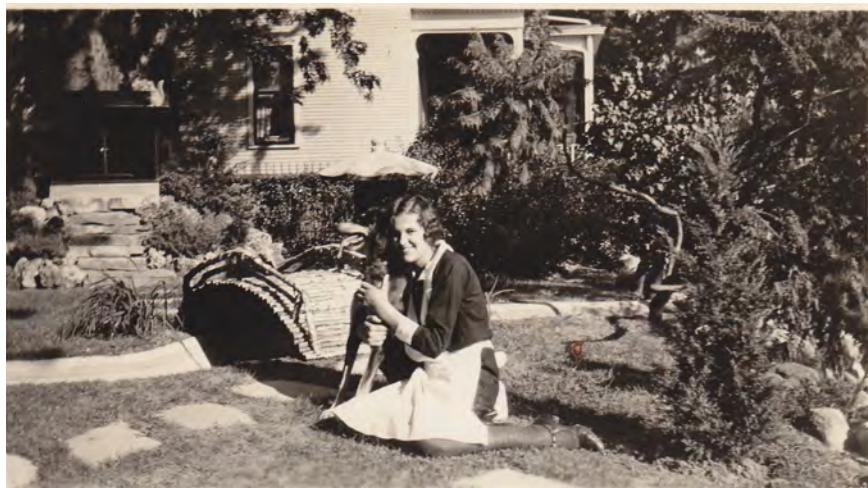
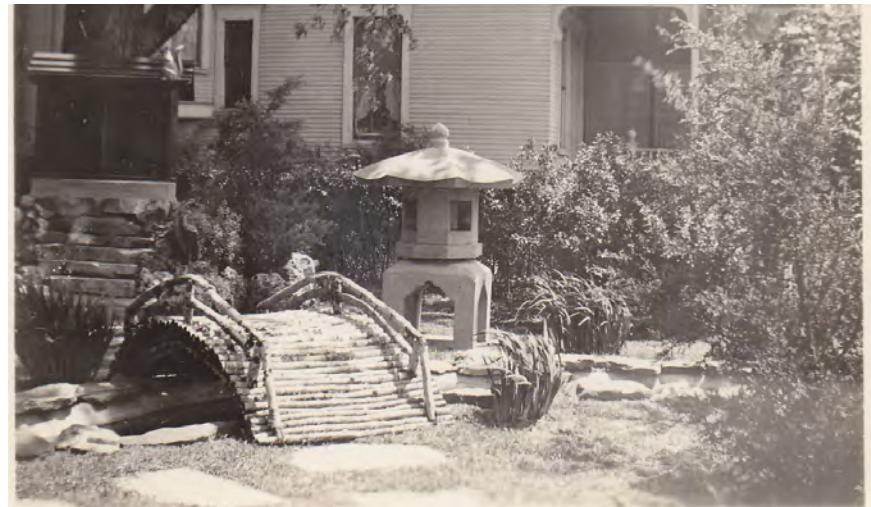
1965.284.1/1964.281.4

- Left photo seems to be earlier; note addition of stones along channel, taller privet hedge in photo on the right.
- Note iris at base of bridge—confirms newspaper accounts.
- Columnar evergreen is one of many that appears at many times—unclear what species; could be juniper or yew; smaller scale.

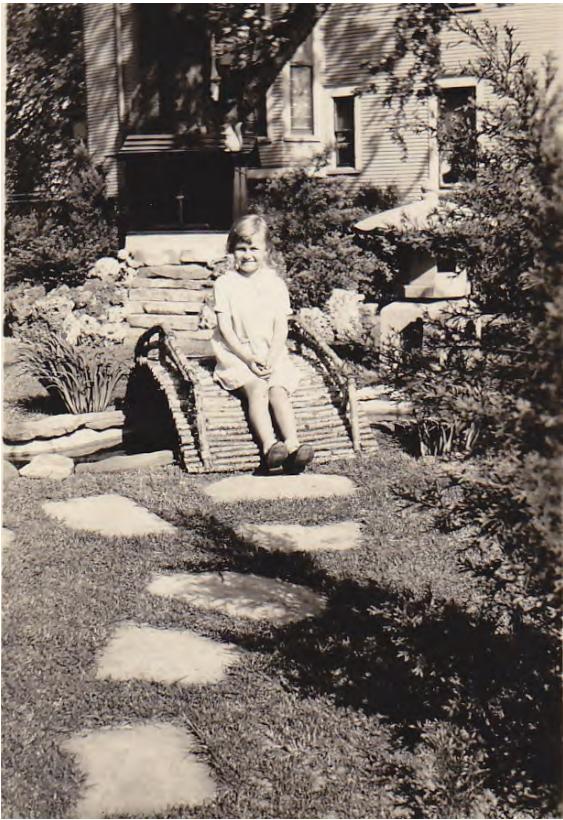
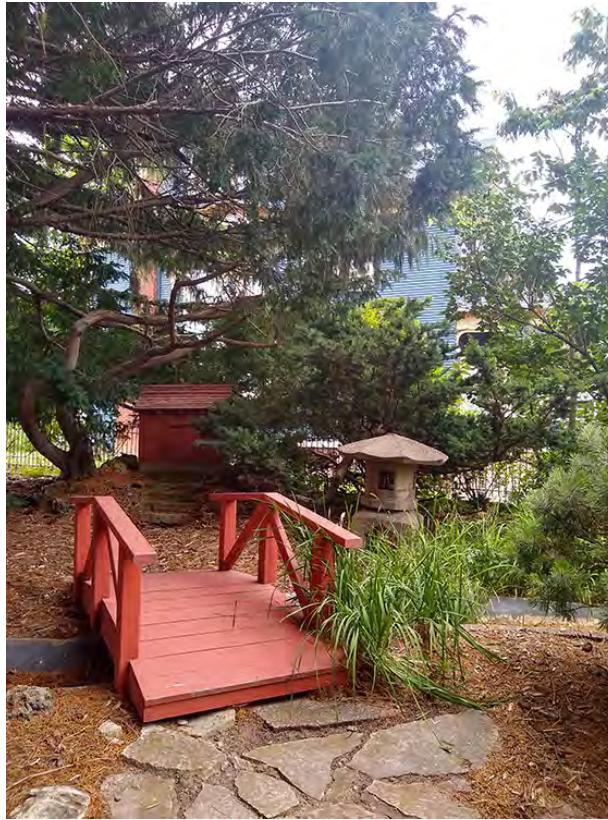
1965.284.29/M-175

- Historic garden has grass and stepping stones.
- Current garden expanded walkway/patio and mulch and needles.
- Current backdrop very dense; note mature Norway spruce vs. high canopied deciduous tree.
- Shrine structure currently dwarfed by surrounding yews.

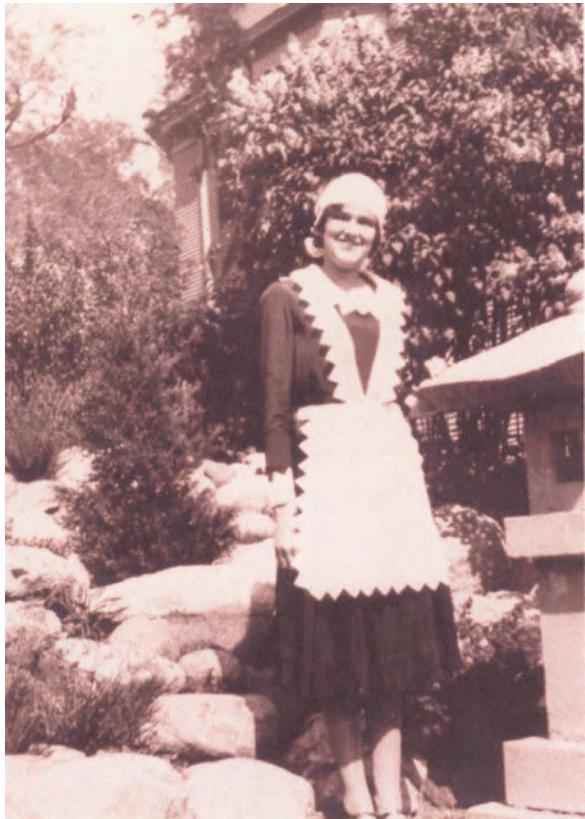
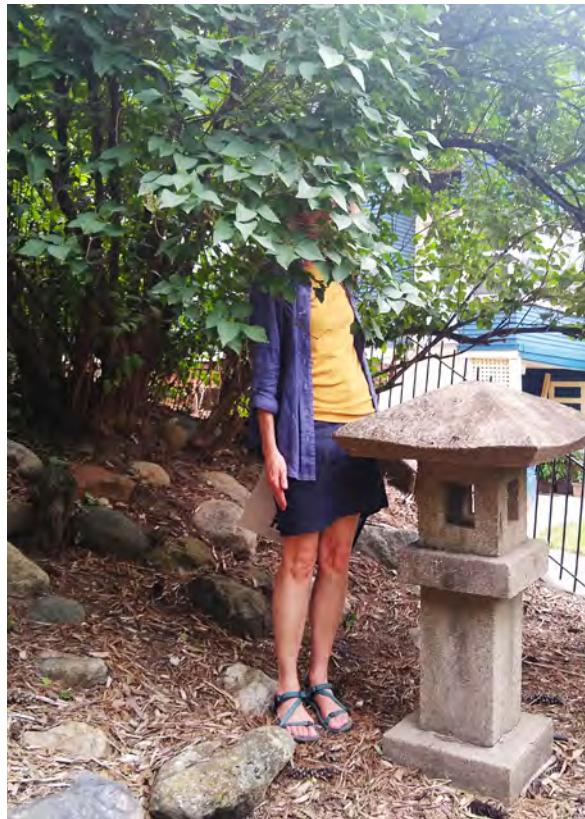
2006.680.i/M-144

- Note historic lilac is still extant historic.
- Note (another) columnar evergreen in historic photo.
- Note how buried base of lantern is today, indicating amount of soil/mulch that should be cleared away.
- Note change in size of stones--some likely buried underneath mulch (?).

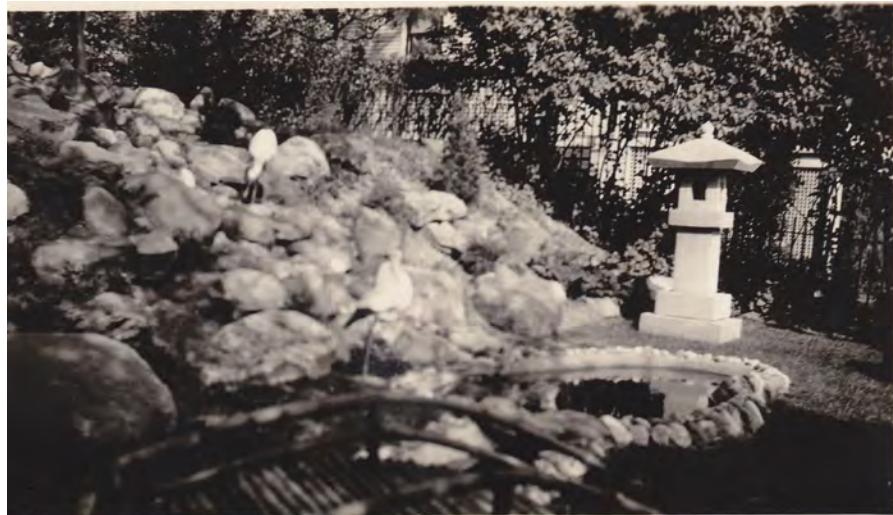
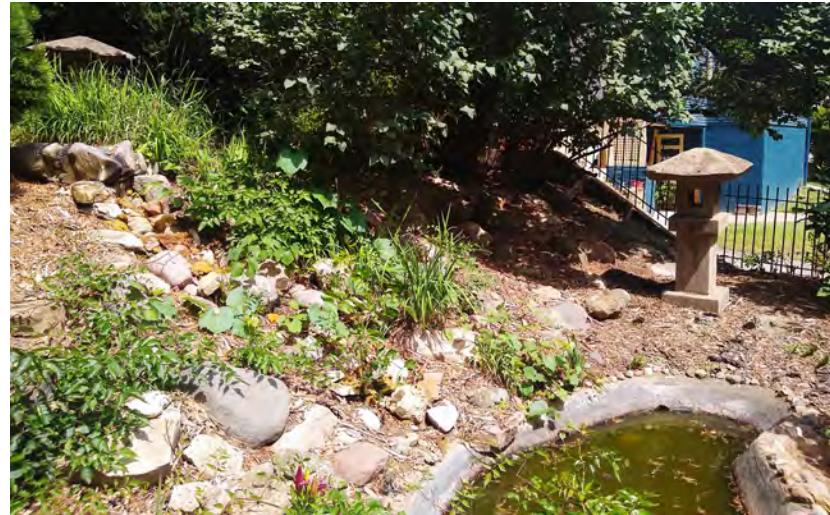
1965.281.6/M-828

- Note buried base of lantern today; note lawn at base of lantern in historic photo.
- Changes in rock size and scale, changes in edging, fill level in pool.
- Note additional sculpture/ibis in historic photo.
- Note columnar evergreen on slope in historic photo.

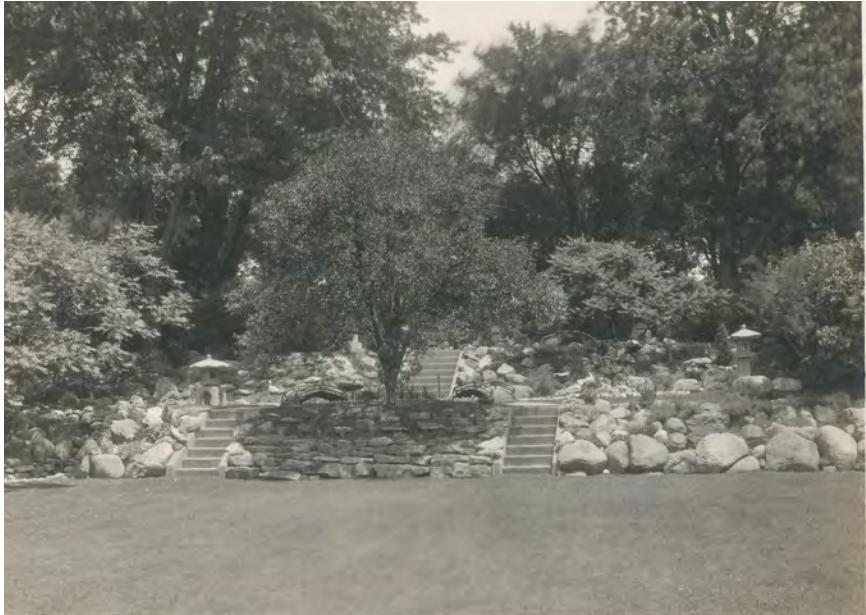
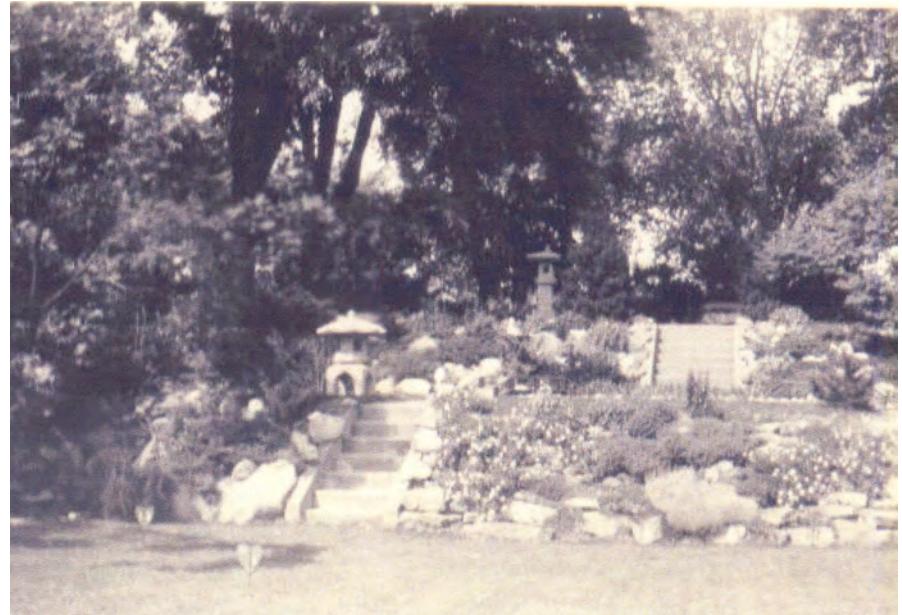
2020.14.b/M-215

- Photo on left is earlier
- Note dimensional stone and mature small tree (crabapple?) between lower staircases.
- Note large stones at base of lower slope, especially in the older photograph on the left.
- Note backdrop of upper canopy backdrop and layers of vegetation in both photographs.
- Note variety and mounded nature of plantings on rocky slope, especially in photograph on the right.

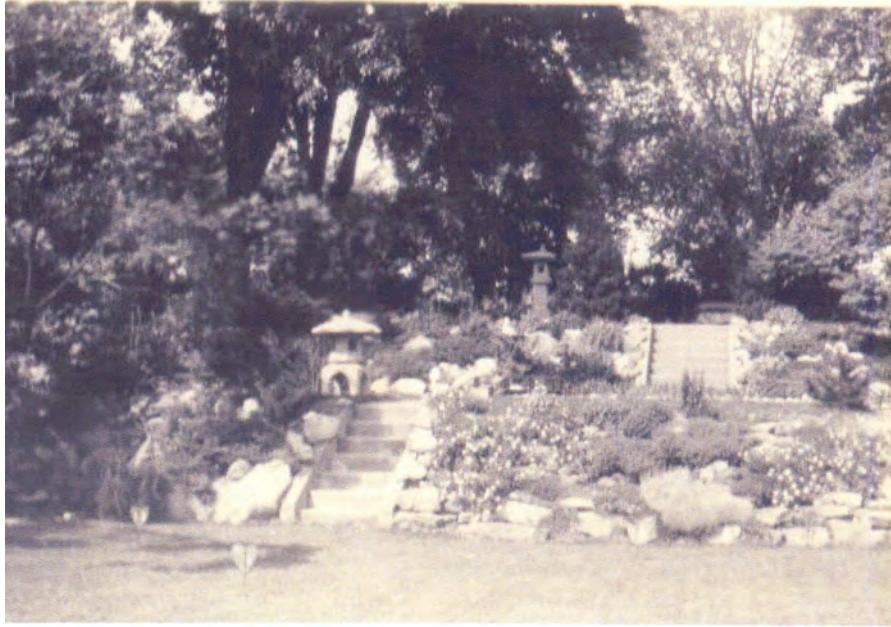
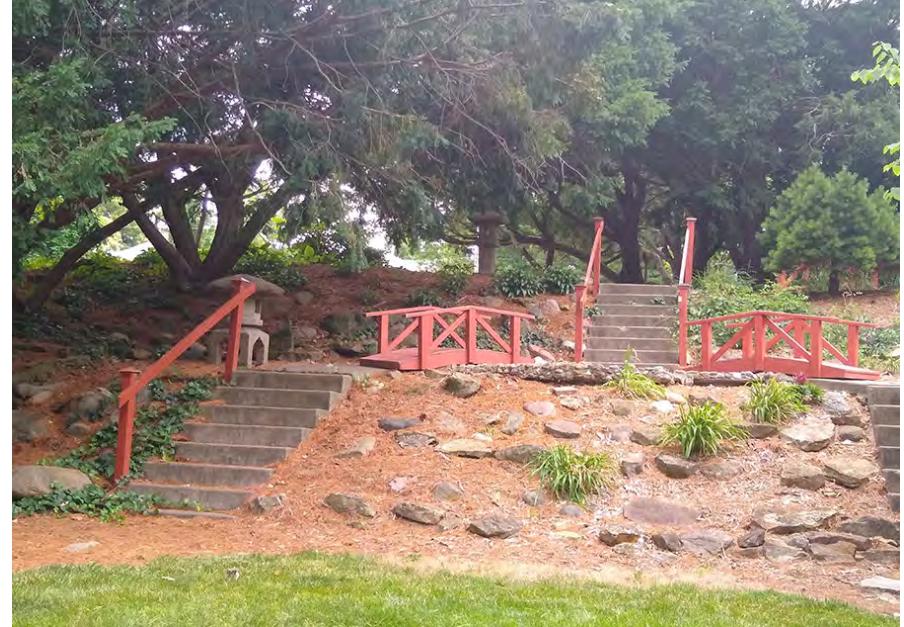
2006.679.a/M-215

- Note loss of cheek walls on stairs.
- Note loss of plantings, loss of large stones in current garden.
- Note of loss of vegetative layering; only upper canopy in current garden—little understory, little ground plane planting.
- Current bridge and railings are visually dominant due to size and color; in historic garden (left), lanterns are dominant.

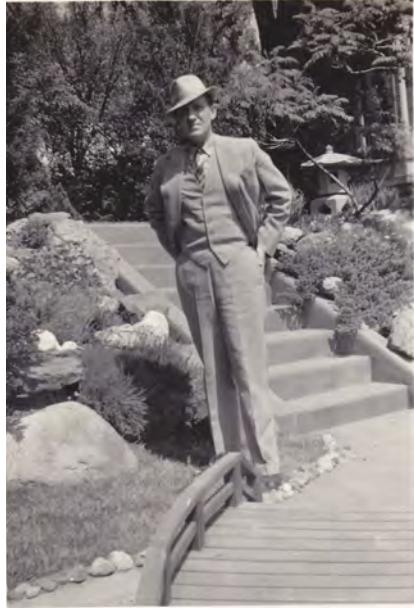
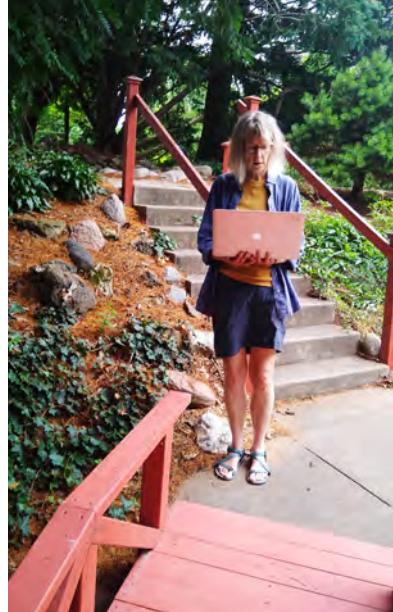
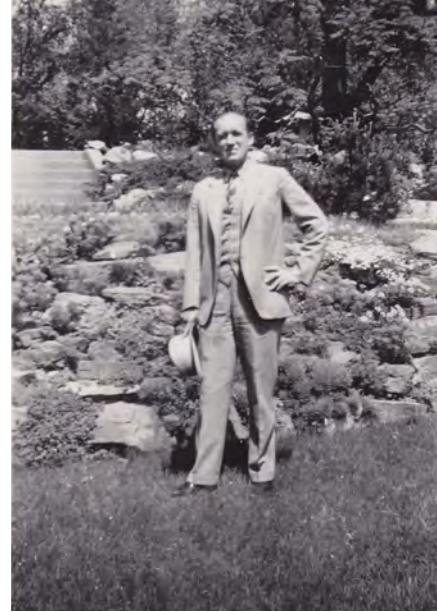
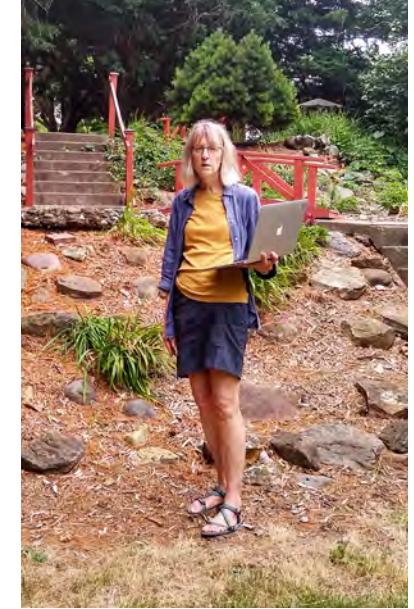
1990.168.9/M-194 and 1990.168.7/ M-358

- Note loss of cheekwalls on staircases.
- Note change in edging along walkway
- Note addition (and visual dominance) of stair railings because of their size and bright color.
- Note the historic photos, circa 1937, show a second version of the bridges with lower side rails and constructed of different wood.

- Replace extant wooden step handrailings with simple, thin, and elegant black cast iron or powder-coated steel railings that recede visually and do not dominate scale of steps.

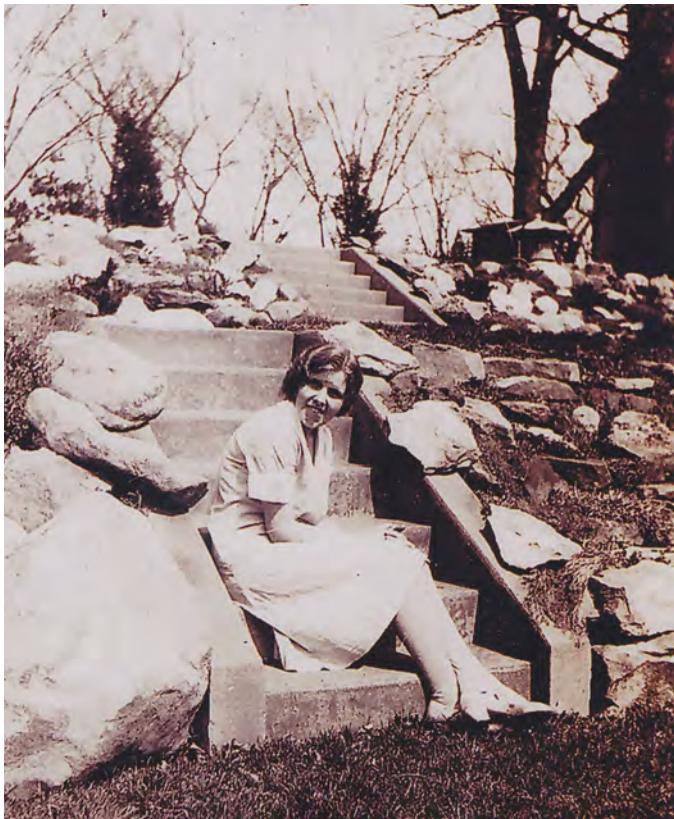
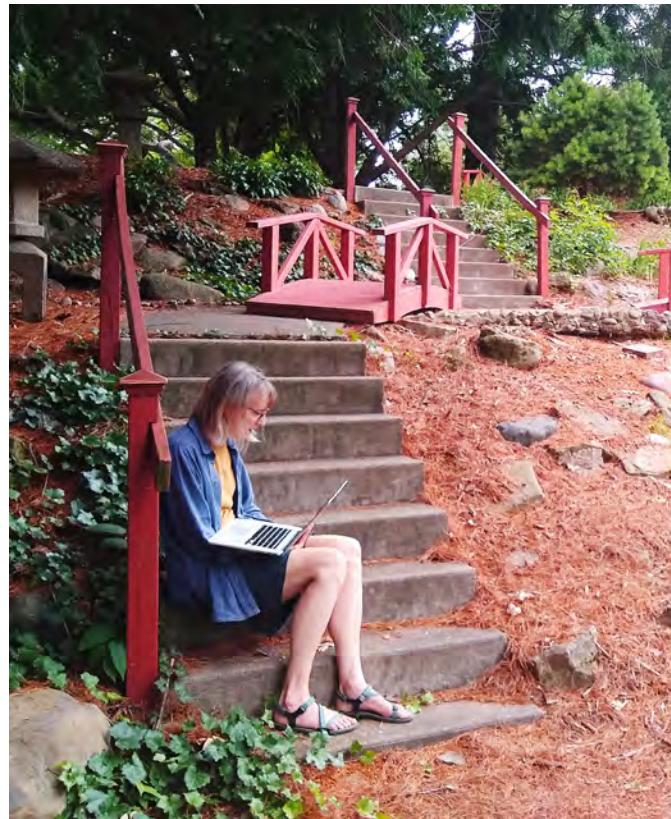
2006.681.a/M-707

- Historic photo dates to after 1930s and is taken in spring or fall (no leaves on trees in background).
- Note changes in stones on lower slope—much smaller today.
- Note columnar evergreens in the background.
- Note dominance of red bridges and railings in current photograph.

- Replace bridges with bridges more closely matching historic bridges in scale, arch, and materials. Red color is probably not historic. A neutral or dark brown or weathered cedar might be more appropriate. Tall vertical railings should be eliminated; if ADA railings are required, use thin metal railings similar to those used on steps.

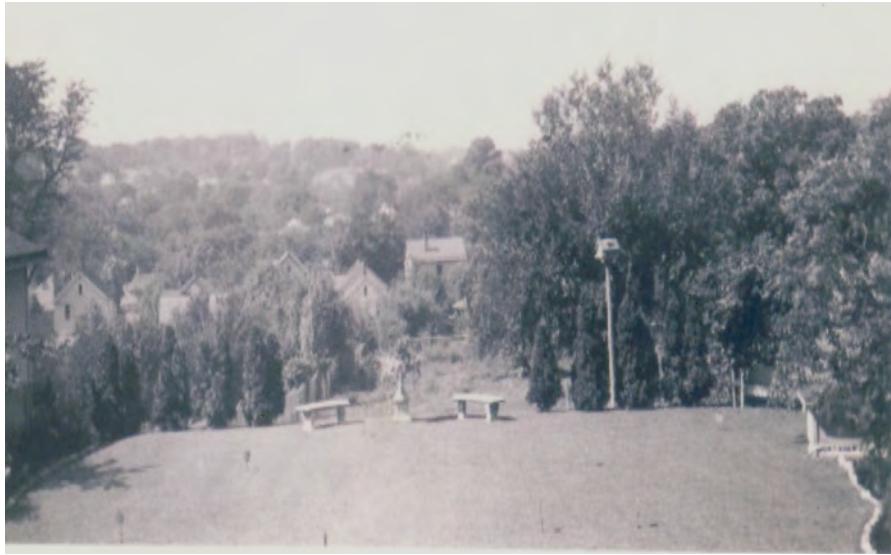
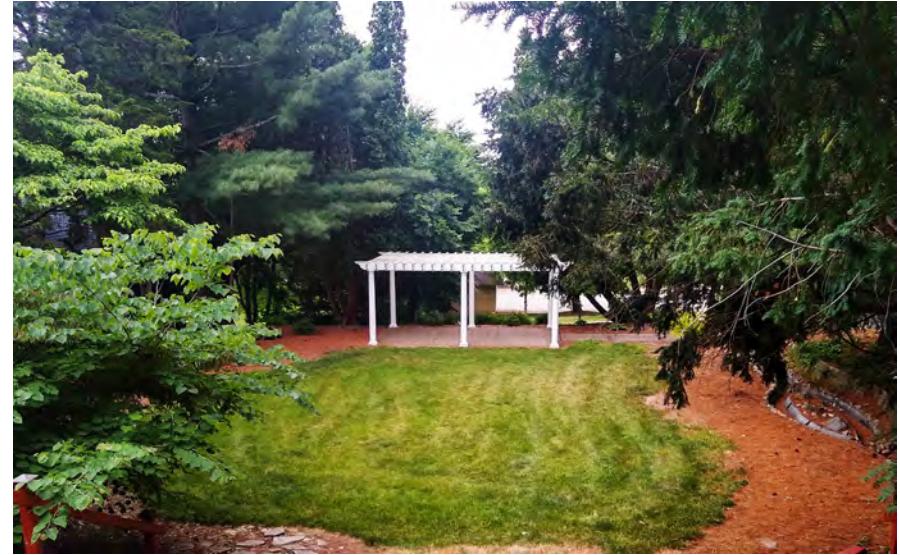
2006.679.c/M-695

- Pergola has replaced benches on garden's central access. Pergola is bright white and draws attention.
- Lawns reduced in scope and changed in shape (due to expanding shade regime).
- Historic view more open; arborvitae seen in historic photo are still extant in some places, terminate garden view.
- Extant stream channel seen in both photos.

- Replace stone edge and planting bed on south side of lawn. Develop planting plan using herbaceous perennials and low growing shrubs.
- Arborvitae here are extant from historic period and mature; pergola has recently been replaced. Undertake this work last or when needed
- Replace extant arborvitae with new arborvitae to return edge to original scale.
- Replace non-historic pergola when it deteriorates. The pergola's current neo-classical style conflicts with garden's Japanese theme and may convey anachronistic character. A new pergola could take on a more Japanese character to reinforce the garden's historic theme. Consider matching material of pergola to bridges to reduce visual clutter.

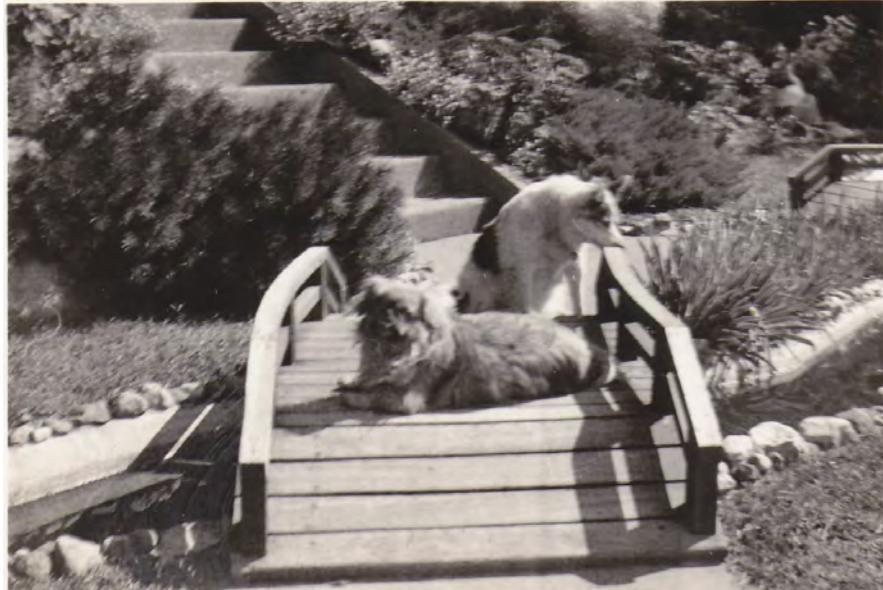
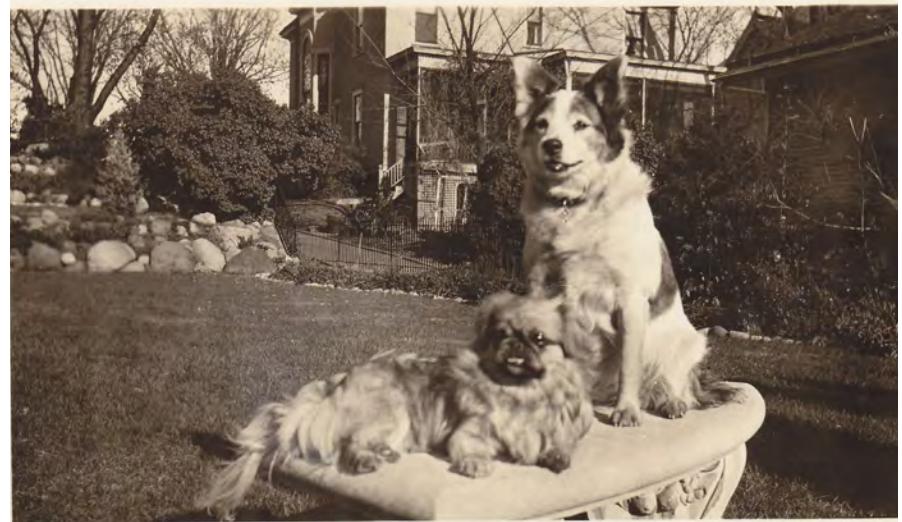
1965.282.2/1965.282.5

- Benches still extant at end of 1930s (dogs in both photos, bridges same as those in Drew Nagel photo).
- Note stone bed edge on south side of lower garden.
- Note mugo pine and juniper on slope; iris along channel, stones along channel and walk.
