City of Muscatine

IN-DEPTH ITEM – CITY COUNCIL

East Hill Multi-Use Facility Direction for Design Consultant

In August 2020, Legat Architects was awarded the contract for a Fire Station Facility Assessment Conceptual Plan. This work included an existing condition assessment of the site and all buildings, cost benefit analysis to construct new or renovate to create a fire station, and a conceptual building design for a new stand-alone fire station or renovation of the existing building into a fire station.

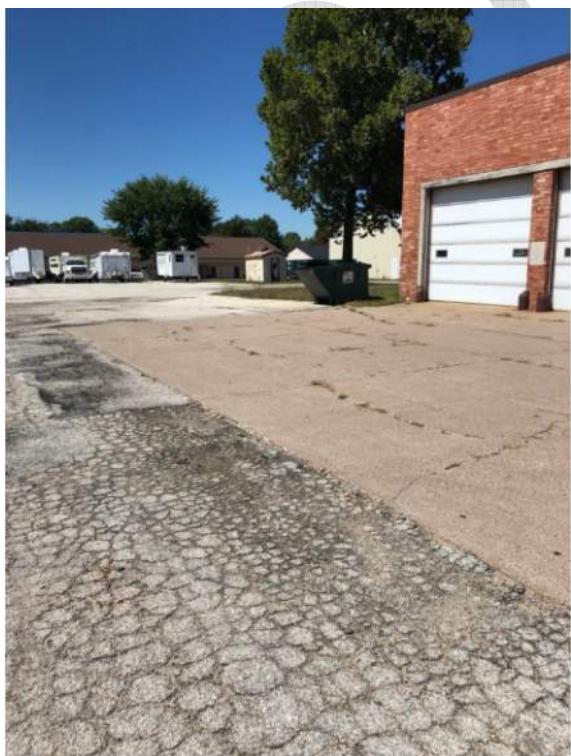
Picture 2: Asphalt pavement and concrete drive south of existing main building. Looking northwest.

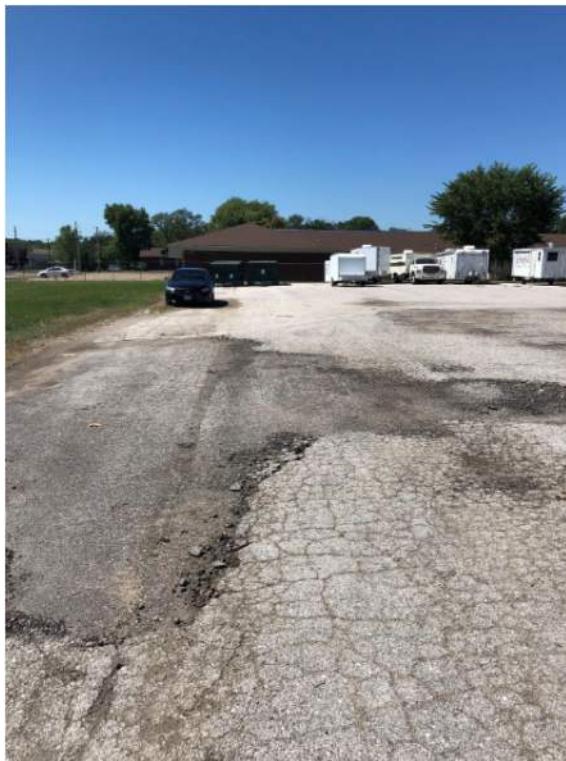
Picture 3: Asphalt pavement south of existing main building. Looking west.

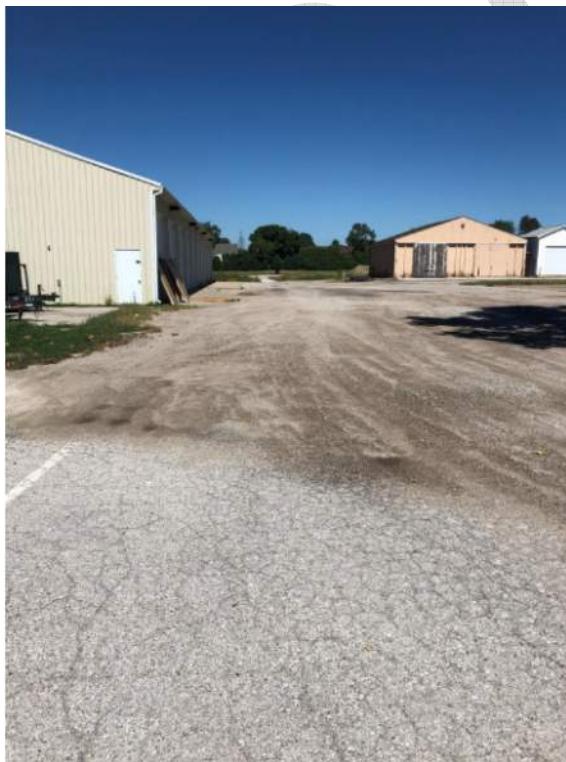
Picture 4: Edge of existing asphalt parking / rock surfacing area west of main building. Looking north.

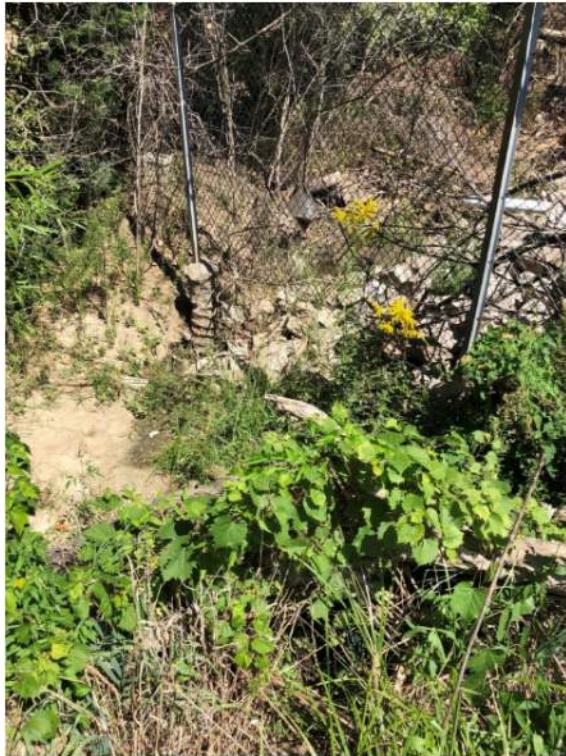
Picture 7: Eroded ditch and fence post footing. Looking northeast.

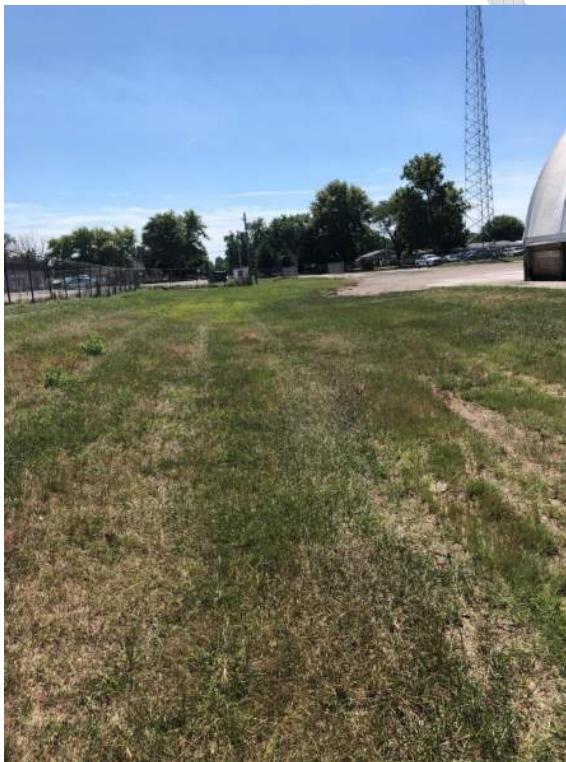
Picture 8: Existing grass area on east side of the site that could be regraded for a ditch draining north from Lake Park Boulevard to the existing drainageway on the north end of the property. Looking south.

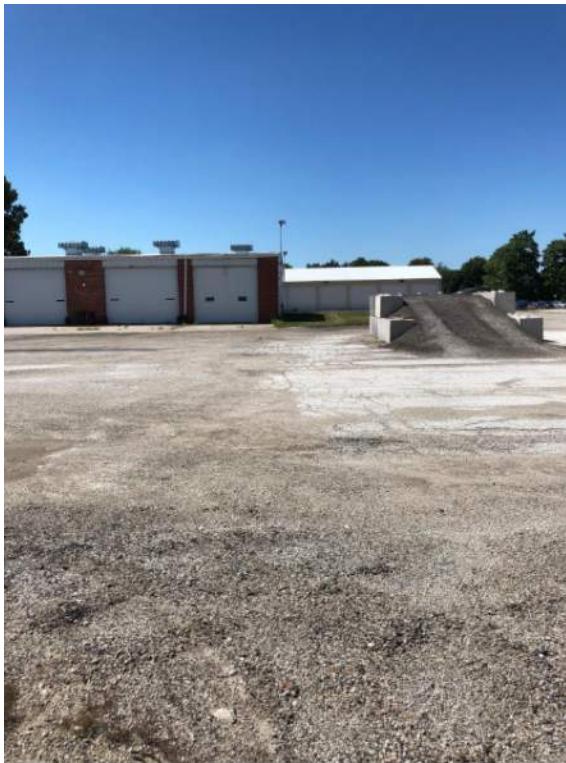
Picture 9: Existing rock and asphalt surfacing east of the main building. Looking west.

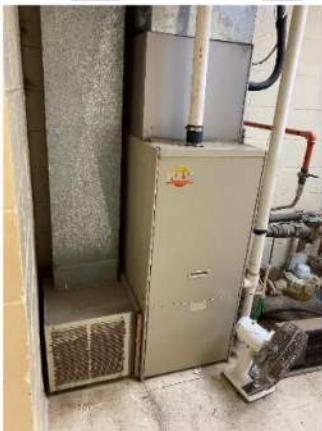
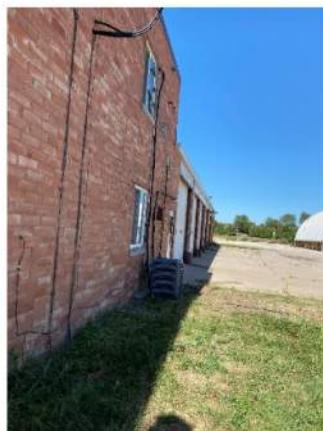
- The existing building is served by a gas fired furnace with DX "A" Coil above it to deliver tempered air via ductwork throughout the office and training area. The Furnace portion of the system has a 1,000 CFM blower fan within it. The A coil is a 2.5 ton coil system with a remote 2.5 ton condensing unit outside. The system has 2014 manufacturing dates on them. The units are not even at 50% life yet. The system does seem undersized for the age of the building (envelope efficiency) and it's predicted load calculation. The building utilizes operable windows for ventilation and not mechanical ventilation which is allowable by code. Depending upon future use of the space and occupancy load, system may have to be upsized before the equipment maxes out it's life expectancy. The CSST gas line to the furnace needs to be grounded, which can easily be done to the incoming water service next to the furnace. Unit is currently controlled with a 7-day programmable Honeywell thermostat. This can't be accessed remotely. Recommend a Honeywell WIFI thermostat at minimum if BAS won't be used in the future for remote alarms and temperature change and monitoring

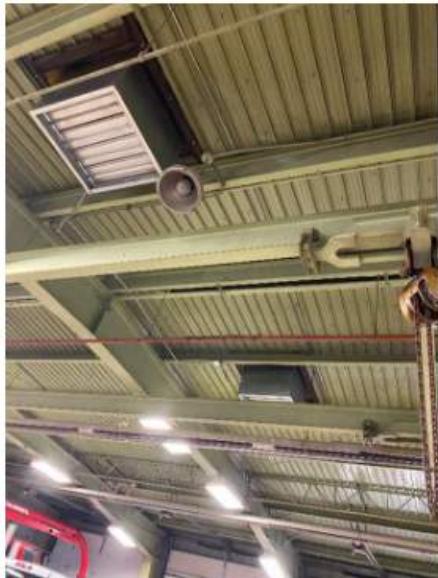
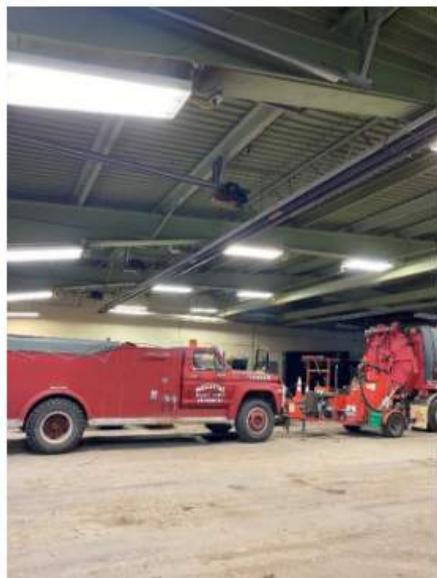
- The additional garage additions off of the main building one with 4 bays and one with 2 bays each have a perimeter loop of infrared gas fired heaters and then two intake louvers with motorized dampers and two exhaust louvers on motorized dampers. The exhaust and intake system appear to be newer (date not found) and in working order. The infrared heaters were also still nicely intact and appears to be newer in comparison to the secured garage. Other than reacting to any change in storage use or the addition of vehicle exhaust as there appeared to be an oil changing station for the fleet in this garage.

It's noted that there is a compressed air loop throughout these garage bays, however the large air compressor has been disconnected and removed. There is exhaust for above the air compressor where the ductwork connections and fan remain. It's recommended to install a new air compressor, compressed air dryer and exhaust system for the heat generated off of the air compressor. This isn't code required but rather recommended for functionality of the building. Existing compressed air piping and valves would need to be pressure tested.

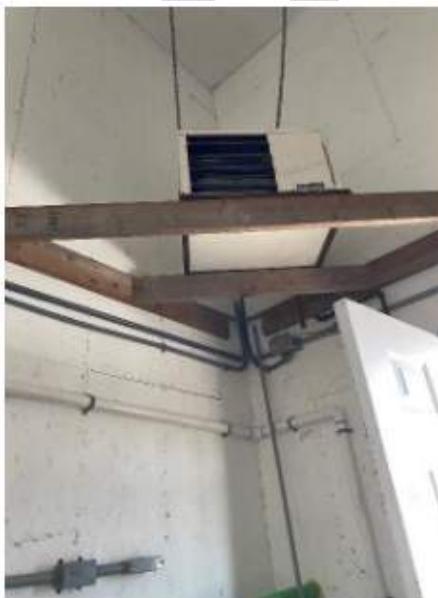
- There is an electric unit heater within the brine mixing building. Appears to be in working order. Unit is mounted high on wooden supports which we would need to review if that's allowable per manufacturer for the heat transfer.

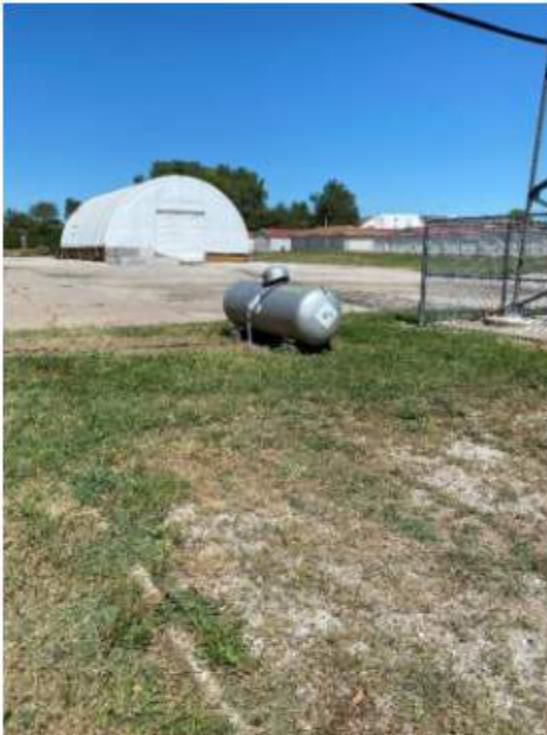
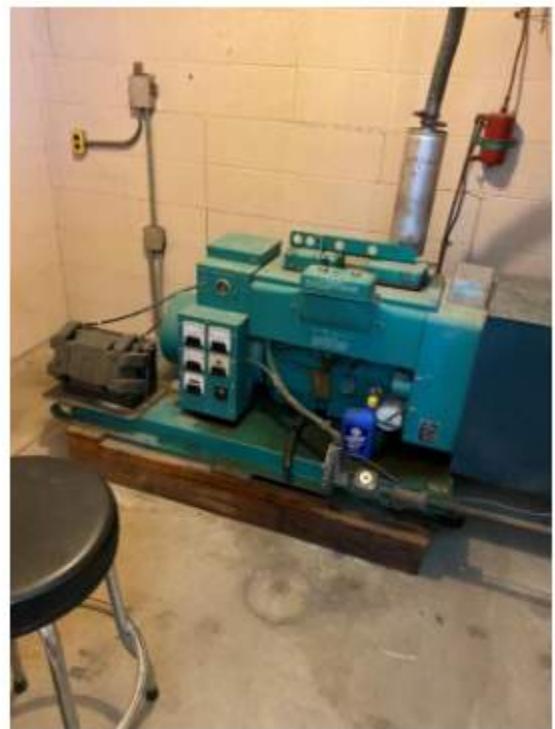
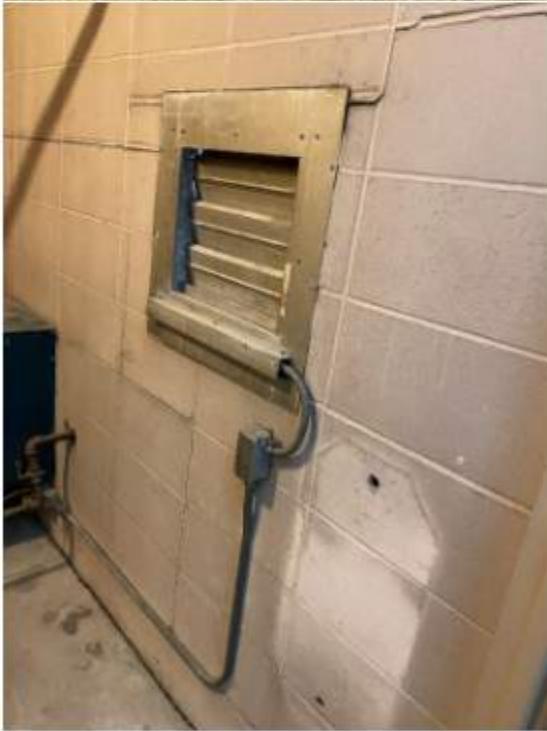
- There is a propane tank on site with gas piping going underground, and then up along side the building to serve the generator. The generator had a ducted exhaust tail pipe, as well as a motorized louver to open in side of the building when unit is running.

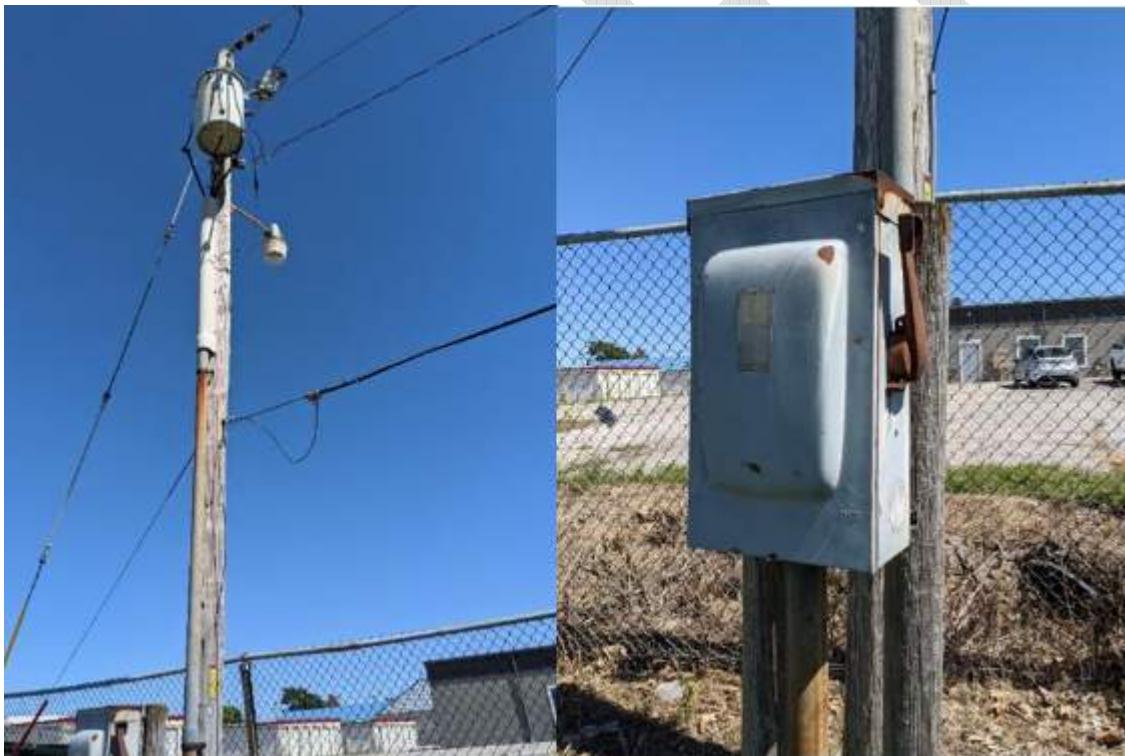
The existing main building is served by a pole mounted utility transformer located on the East property line (below left). The utility pole has a 400A main disconnect (below right) mounted in front of it.

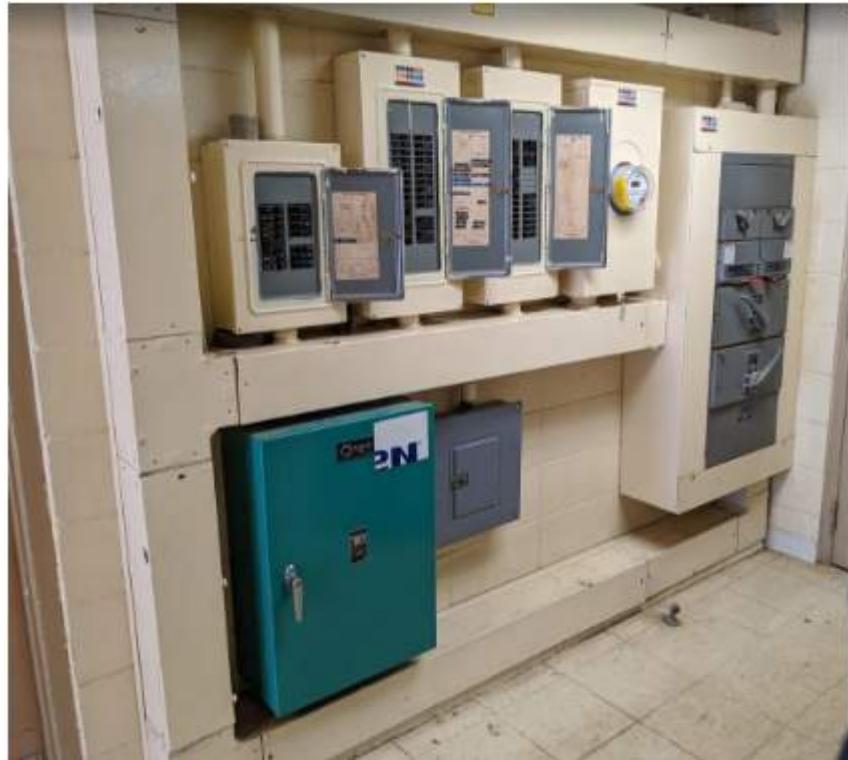
Panelboards A, B, C, and E, the main electrical meter, and the 400A fused switchboard are all located on the West wall of the main corridor.

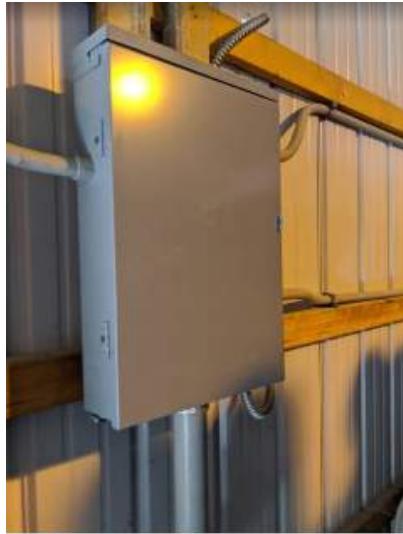
The shed located on the West part of the complex is fed with a 100A panelboard (below) fed from panelboard B.

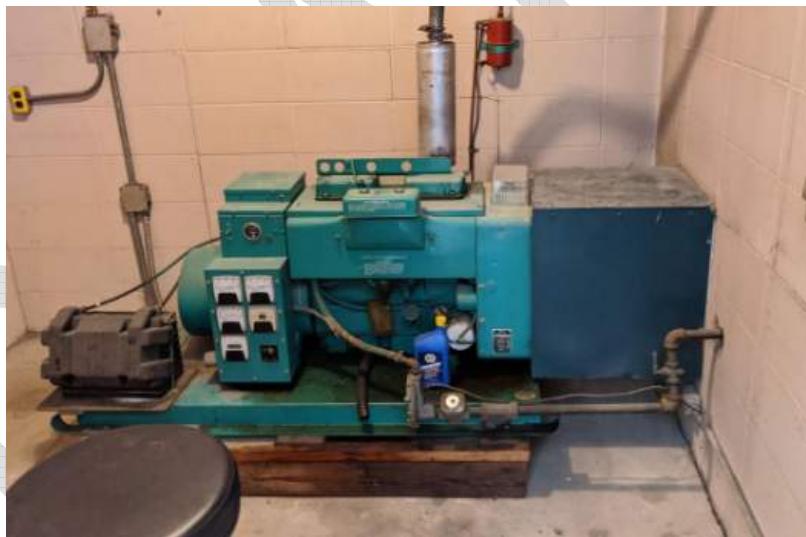
There is an emergency 12.5kVA Onan generator (below) located on the second floor of main building. It serves an automatic transfer switch located on the same West wall as the other electrical equipment. This emergency generator looks to be a secondary source of power for panel A. Panels A loads include the buildings emergency lights, a diesel pump, and some other general loads.

The existing service was observed to be sufficient but at capacity.

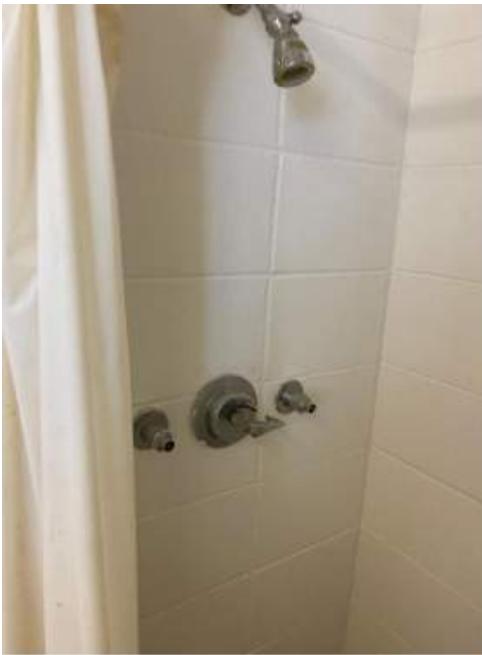
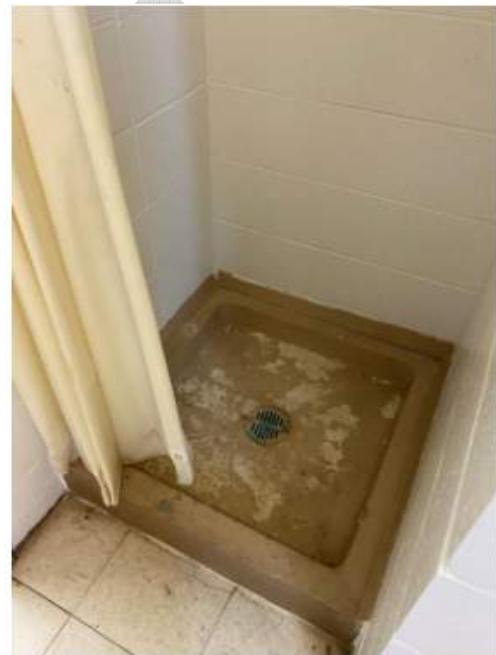
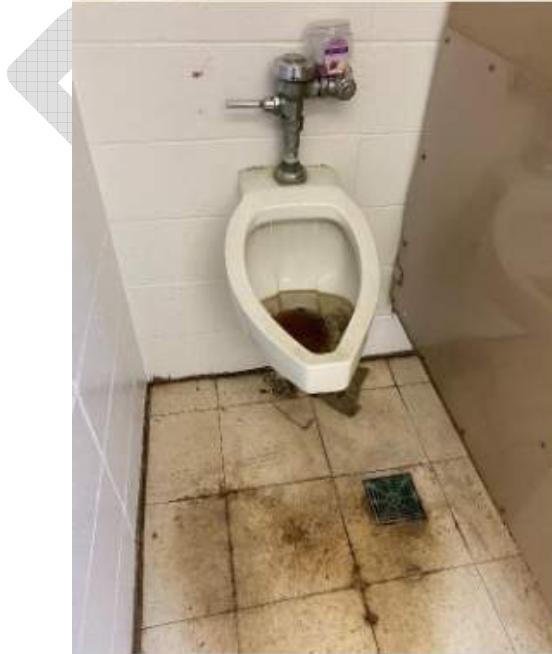
- The existing plumbing fixtures are in rough shape and should be replaced with new. It's also noted that there is one bathroom for the facility. Depending upon occupancy counts, two will probably be required, both with ADA toilets and lavatories. Drinking fountain provides water flow, but no cooling of water. Slop sink on second floor could be replaced and there is a condensate drain line down to the unit that should be routed to an open site drain.

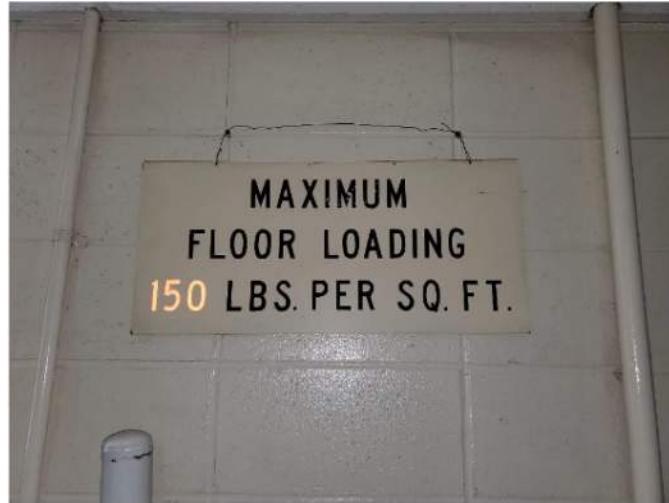
Figure 7. Second Floor Load Rating

The eastern half of this southern portion of the building consists of a two story space, with office and bathroom facilities on the first floor and a conference room and storage rooms on the second floor. The floor structure is a 6" to 8" concrete slab with a posted load rating of 150 psf (see Figure 7). The western half of the building is a three bay garage structure (see Figure 6).

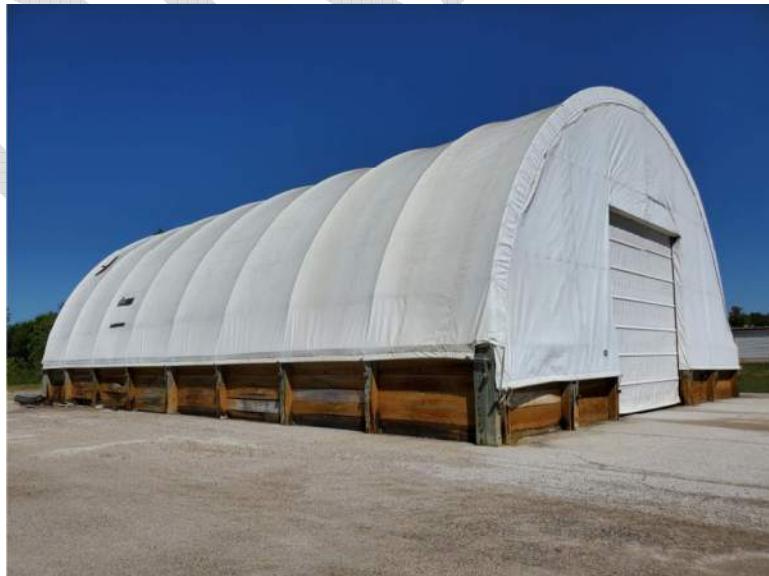
Figure 9. Out-Building 1

The roof of out-building 1 consists of a plastic membrane roof supported on steel arches with walls consisting of wood planking spanning between wood posts (see Figure 9).

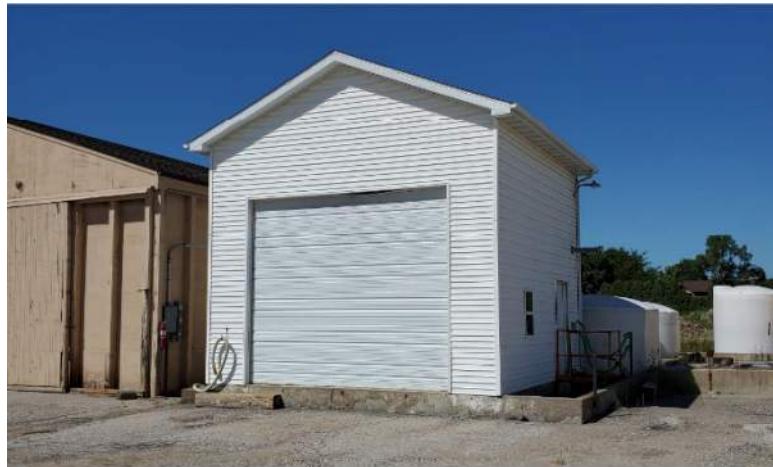
Figure 13. Out-Building 2

Out-building 2 consists of a conventionally framed wood structure with a large garage door on the southern face (see Figure 13).

The building is surrounded by a concrete containment wall, encompassing the building and the small tank farm to the north of the building. Cracking was noted at several locations along the foundation/containment wall (see Figure 14 and Figure 15).

- If the tank farm is to be removed or will no longer need containment, determine if the wall is integral to the building foundation and remove the walls if found to be separate from the building foundation.
- If the tank farm is to be removed or will no longer need containment, patch the cracks in the exposed faces of the wall to prevent further crack growth.
- If the wall is to remain and is necessary for containment, excavate to expose the entire wall depth for the entire perimeter, inspect for further cracks, and repair the cracks in the wall with a sealing concrete or epoxy.

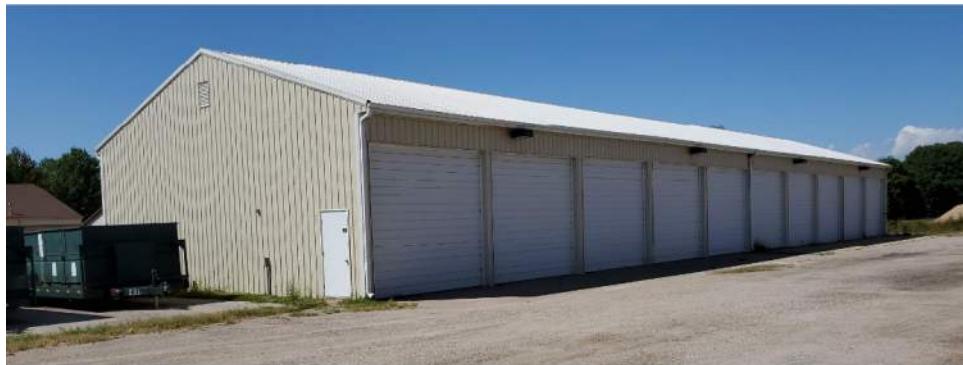
Figure 20. Out-Building 4

Out-building 4 is a wooden pole building with metal siding (see Figure 20).

The building is relatively new and, as such, is in very good condition. However, during inspection, an animal burrow was discovered beneath the building slab on the building's west side (see Figure 21). This cavity in the soil beneath the slab can undermine the floor slab, reducing its strength resulting in undesirable cracking and settlement.

- Remove the animal from the burrow and fill in the cavity with a flowable concrete fill.
- Replace the damaged base boards with pressure-treated, ground-contact rated lumber or add additional concrete around the building base to enclose the poles and protect them from the elements.

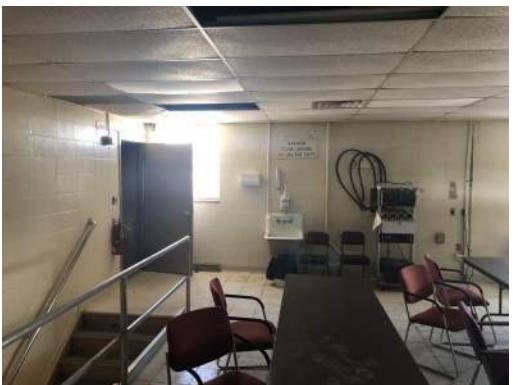
① HANDRAIL EXTENSIONS ARE REQUIRED AT THE TOP AND BOTTOM OF STAIR

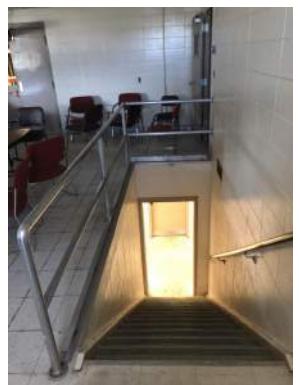
② PROVIDE ADDITIONAL HANDRAIL AT STAIR

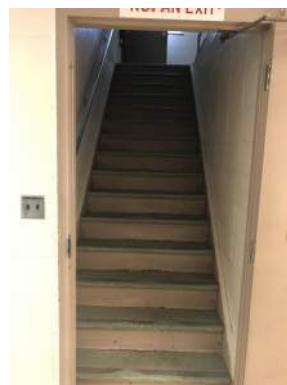
③ PROVIDE LANDING AT BASE OF STAIR

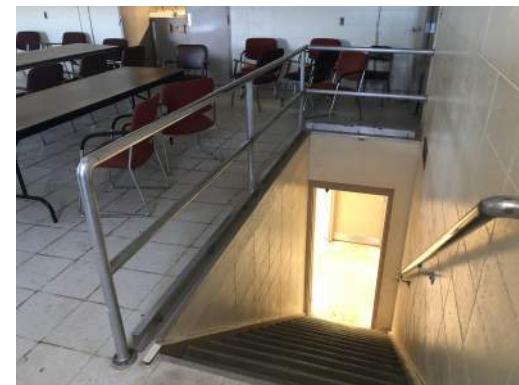
④ PROVIDE 42" GUARDAIL AT STAIR

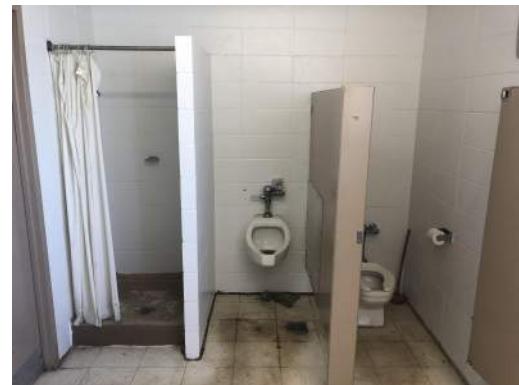
⑥ REMOVE EXISTING TOILET PARTITIONS AND FIXTURES, LAVATORY, AND SHOWER STALL AND REPLACE WITH ADA COMPLIANT FIXTURES AND PARTITIONS

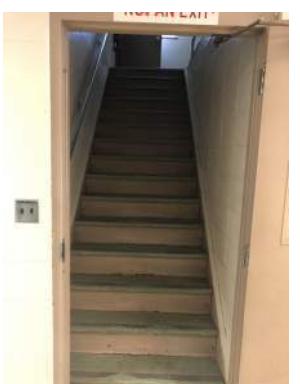
⑦ PROVIDE NEW ANTI-SLIP TREAD TAPE AT STAIR NOSINGS

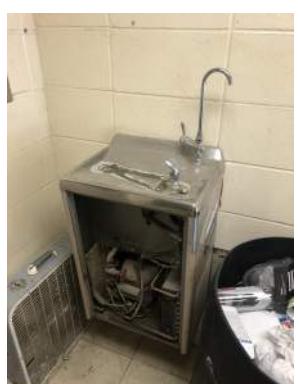
⑧ RELOCATE DRINKING FOUNTAIN TO PROVIDE PROPER ADA CLEARANCE AT DOOR JAMB

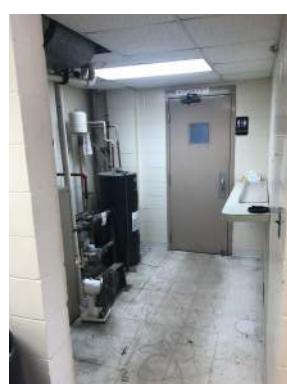
⑨ REMOVE EXISTING COUNTERTOP TO MAINTAIN ADA CLEARANCE AT DOOR JAMB

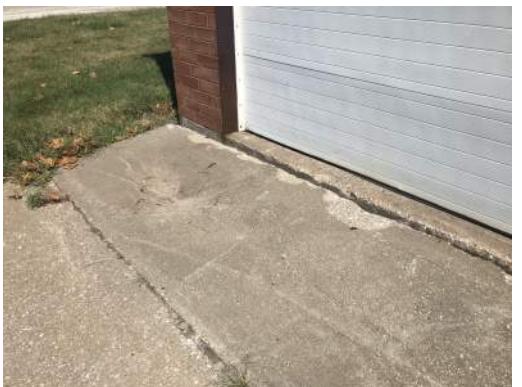
① REPLACE CRACKED AND SETTLED CONCRETE

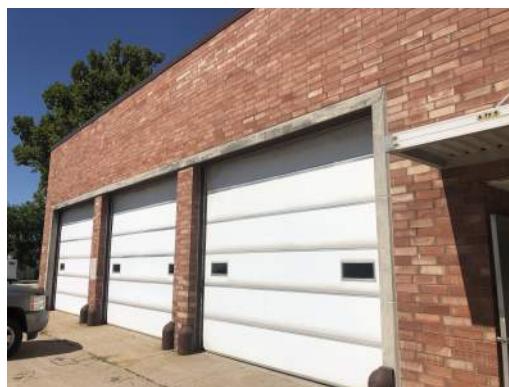
② PATCH AND REPAIR CRACKED STONE

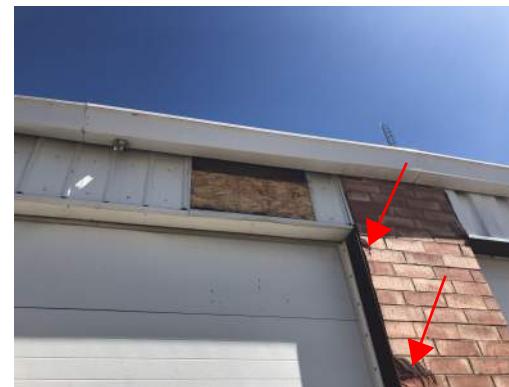
③ REPLACE CRACKED OR SPALLED BRICK

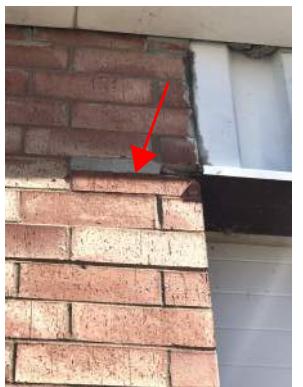
③ REPLACE CRACKED OR SPALLED BRICK

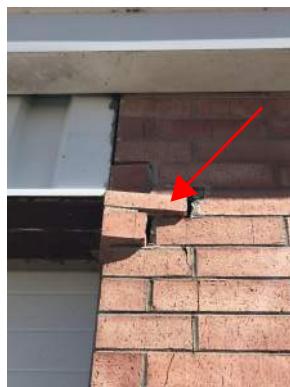
③ REPLACE CRACKED OR SPALLED BRICK

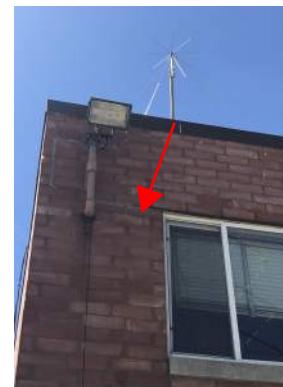
③ REPLACE CRACKED OR SPALLED BRICK

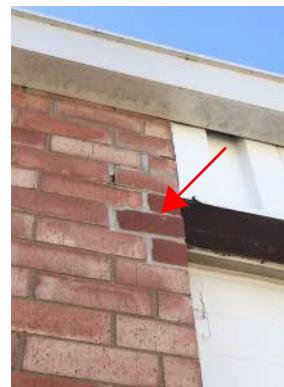
③ REPLACE CRACKED OR SPALLED BRICK

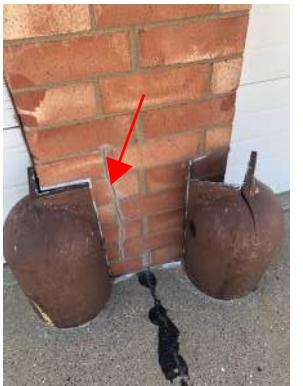
③ REPLACE CRACKED OR SPALLED BRICK

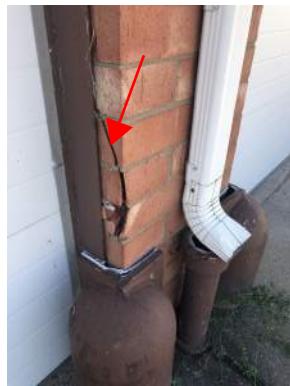
③ REPLACE CRACKED OR SPALLED BRICK

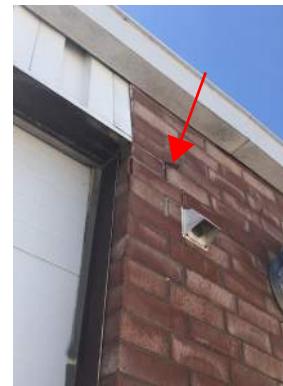
③ REPLACE CRACKED OR SPALLED BRICK

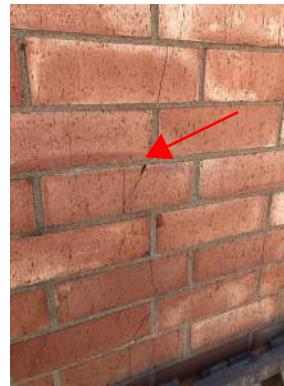
③ REPLACE CRACKED OR SPALLED BRICK

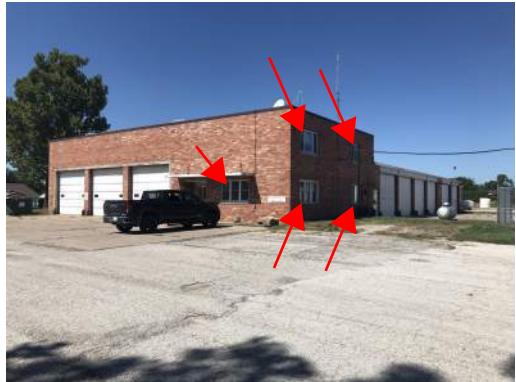
③ REPLACE CRACKED OR SPALLED BRICK

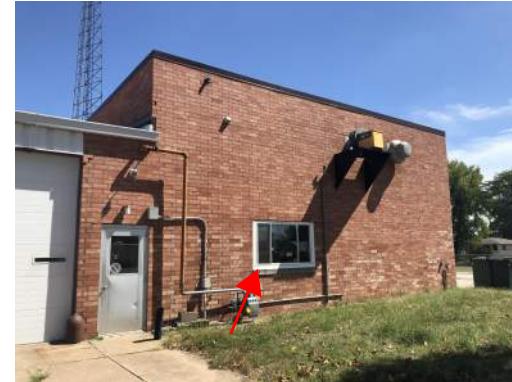
④ REPLACE SEALANT AROUND WINDOW

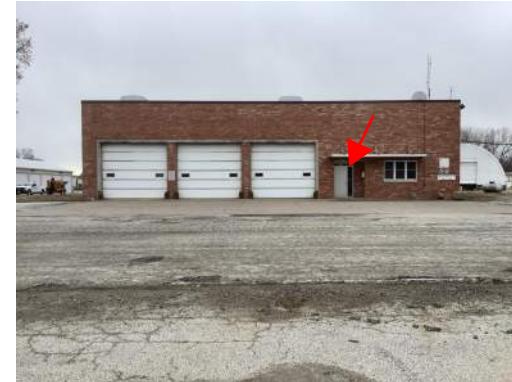
⑤ REPLACE SEALANT AROUND DOOR

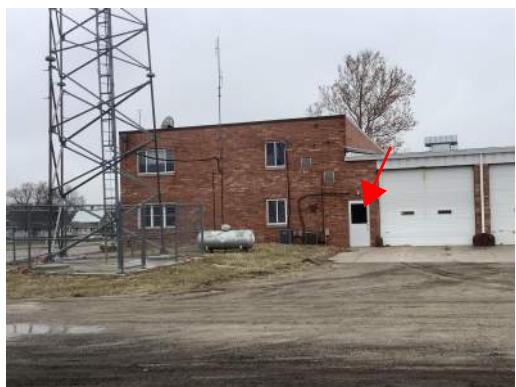
⑤ REPLACE SEALANT AROUND DOOR

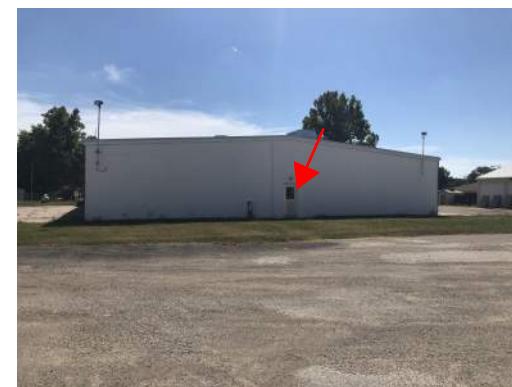
⑤ REPLACE SEALANT AROUND DOOR

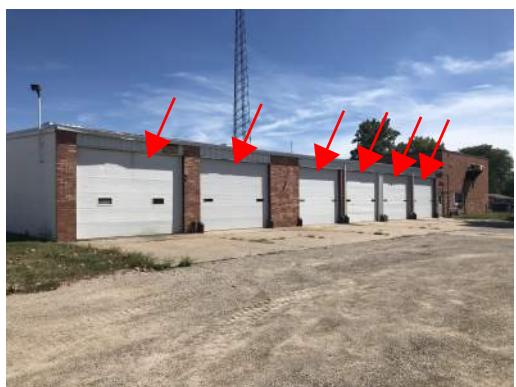
⑦ SCRAPE, PRIME, AND PAINT EXISTING STEEL LINTELS

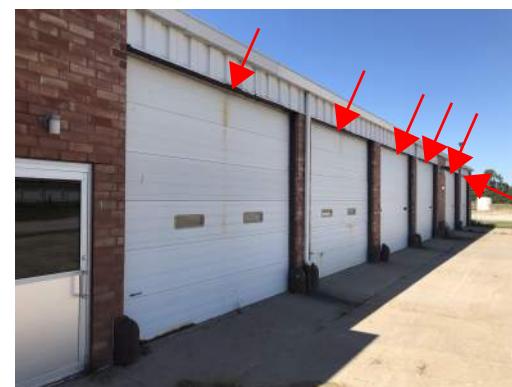
⑦ SCRAPE, PRIME, AND PAINT EXISTING STEEL LINTELS

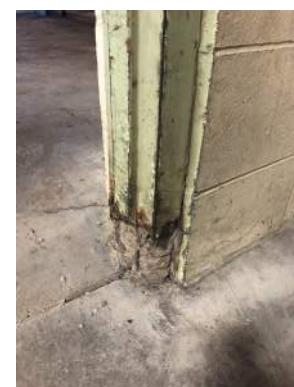
⑧ REPLACE RUSTED DOOR AND FRAME ASSEMBLY

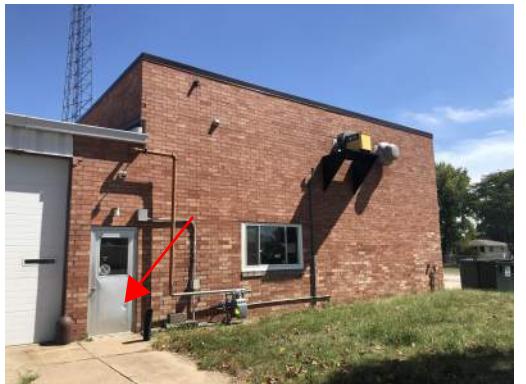
⑧ REPLACE RUSTED DOOR AND FRAME ASSEMBLY

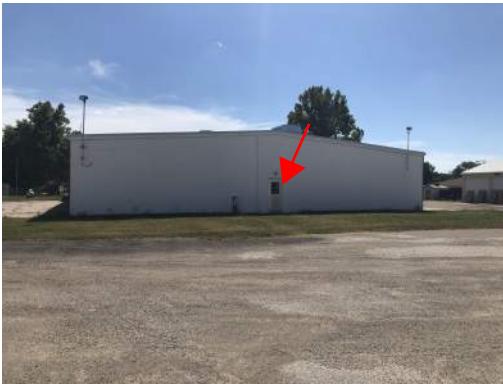
⑨ REPLACE DAMAGED DOOR

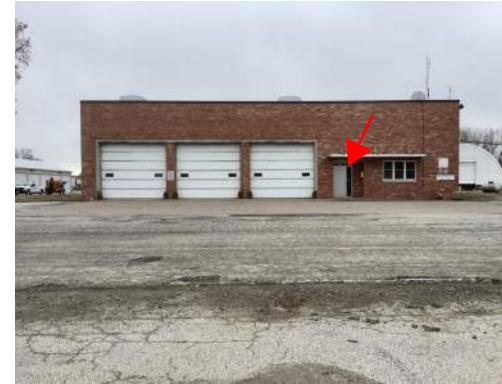
⑨ REPLACE DAMAGED DOOR

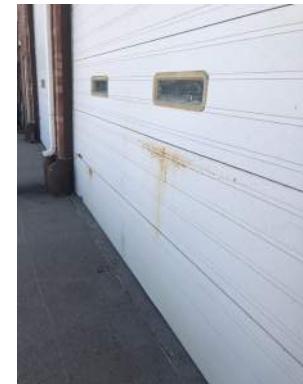
⑨ REPLACE DAMAGED DOOR

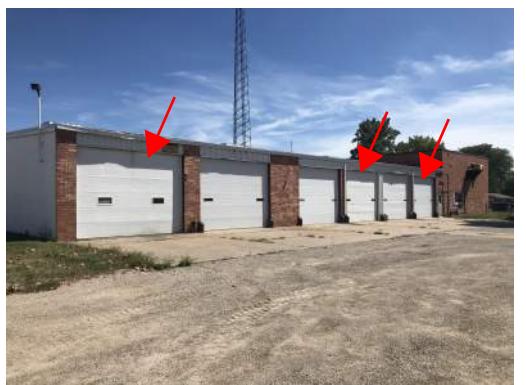
⑩ REPLACE RUSTED OVERHEAD SECTIONAL DOOR

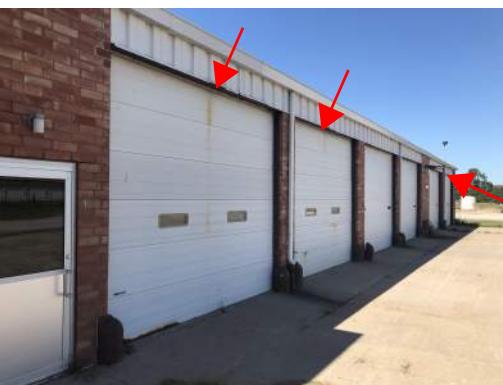
⑩ REPLACE RUSTED OVERHEAD SECTIONAL DOOR

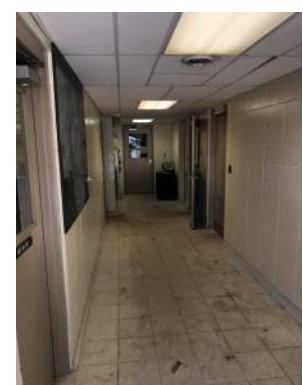
⑪ REPLACE MISSING CEILING TILES

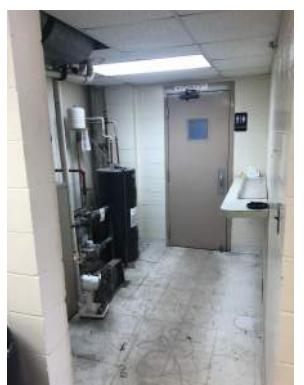
⑫ REPLACE FLOOR TILE

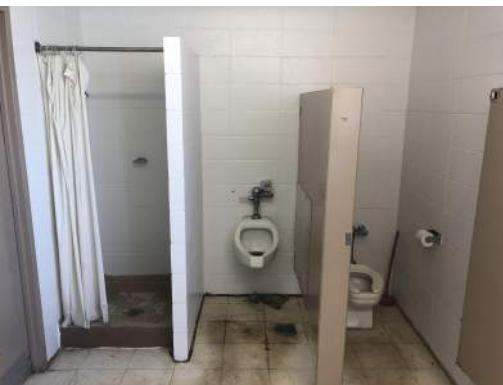
⑫ REPLACE FLOOR TILE

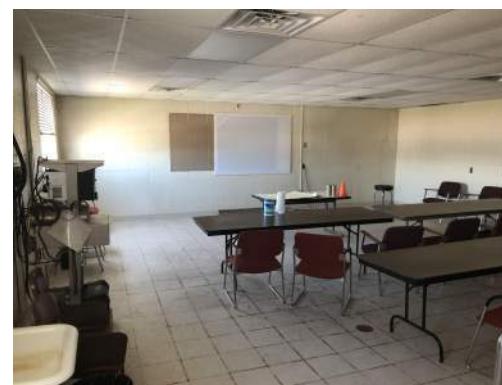
⑫ REPLACE FLOOR TILE

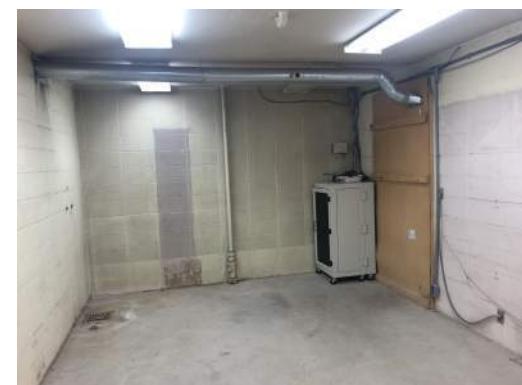
⑫ REPLACE FLOOR TILE

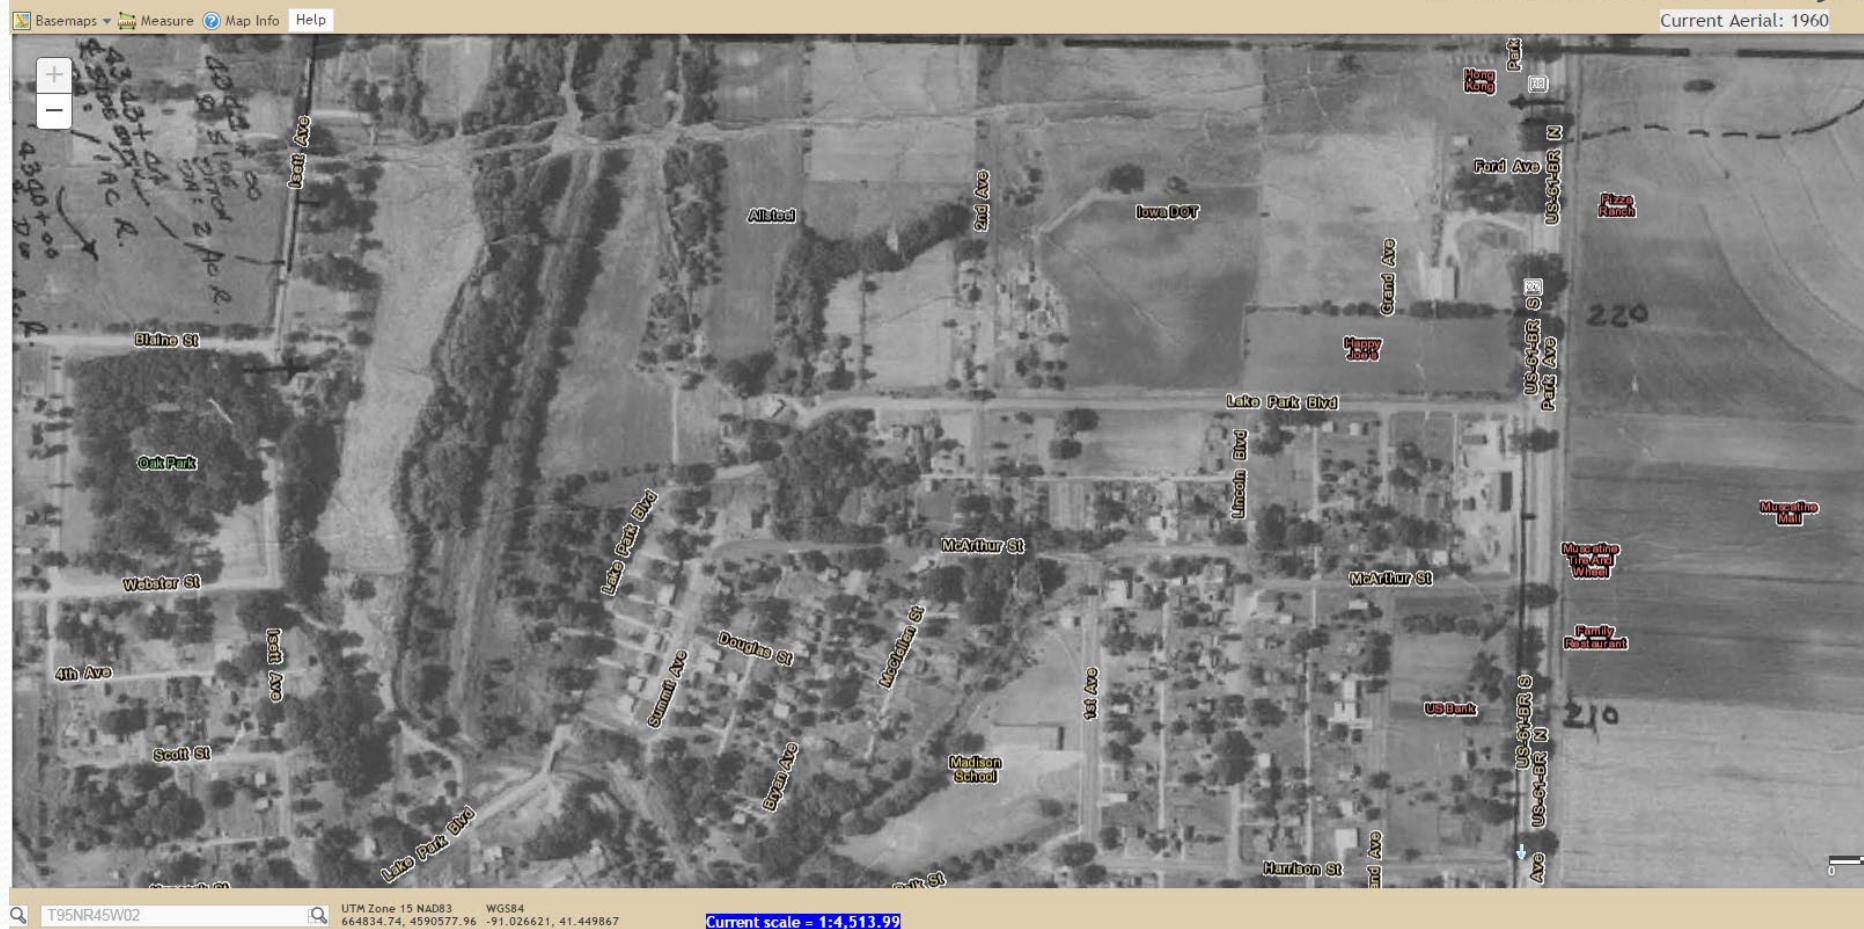
EXISTING CONDITIONS:

- 140 AC \pm DRAINAGE AREA MADE UP OF 2 PARTS:
 - * EX. STREAM (100 AC \pm)
 - * LAKE PARK BLVD STORM SEWER (40 AC \pm)
- FLOODED AREA FLOWS OVERLAND TO MAD CREEK DURING HEAVY RAINFALL.
- FLOODED AREA STAYS FLOODED FOR ABOUT 3 HOURS DURING A 100-YEAR STORM EVENT.
- FLOW IS ABOUT 550 CFS AT PEAK OF 100-YEAR STORM (200 CFS ARE IN THE 48" STORM PIPE)
- OPEN THROAT INLET CAN PASS 5 - 10 CFS.
- WOULD NEED 35 - 70 ADDITIONAL INLETS PLUS ADDITIONAL PIPES TO CARRY WATER TO CREEK.
- NOT ENOUGH ROOM.

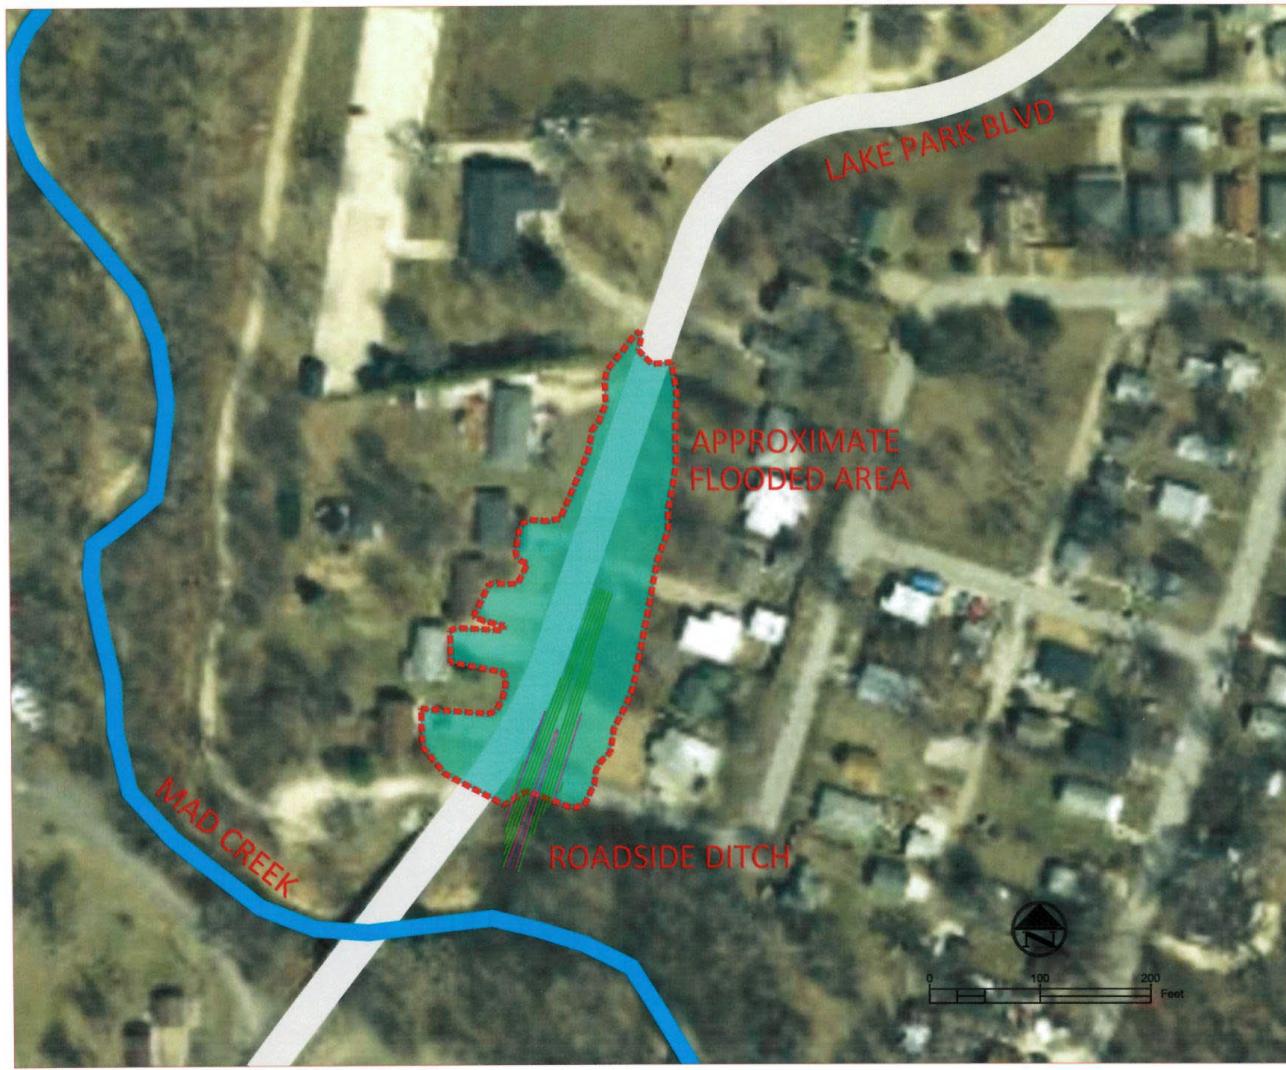
Option 7

ROADSIDE DITCH:

- FLOODED AREA IS THE SAME AS EXISTING CONDITION.
- FLOODED AREA STAYS FLOODED FOR ABOUT 20 MINUTES.
- APPROXIMATE PROJECT COST: \$100,000

- Diversion Ditch on Lake Park Blvd.
 - Design & construction of stormwater project on east side of Lake Park Blvd.
 - Would reduce some water on Lake Park Blvd.
 - Would not eliminate street flooding
 - Would reduce depth & duration of street flooding
 - Estimated Cost \$100,000
